DESTRUCTIVE EFFECTS OF THE 2003 BAM EARTHQUAKE ON STRUCTURES

S.M. Zahrai* and M. Heidarzadeh

ABSTRACT

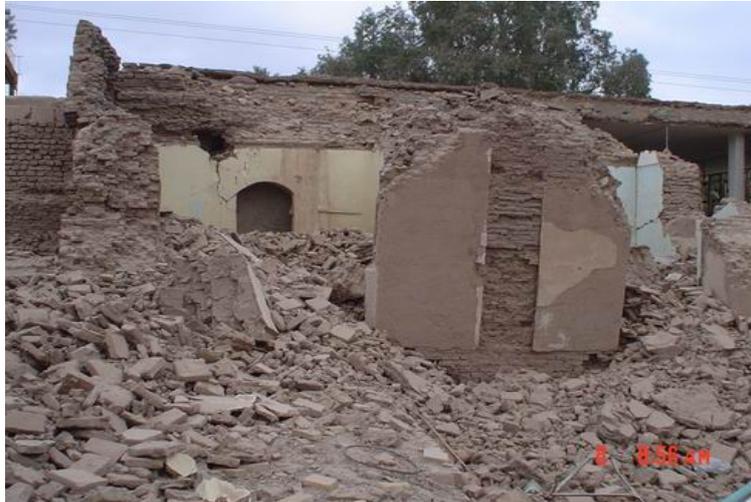
Most houses in the epicentral area are adobe construction, usually one-story made of sun-dried brick walls, and domed roofs or vaults with clay or mud mortar. This type of construction is common in the dry areas of Iran because adobe houses need only local materials and can be built by farmers when their work is lax. The walls and roofs of these houses are thick (usually 40 to 80 cm) and heavy so that they easily protect their inhabitants from the cold and hot weather, but they are very weak in resisting horizontal vibrations particularly at the junctions of vertical walls and domed roof (Figure 4). Based on the reconnaissance visit, most adobe houses in the epicentral region are either partially or totally collapsed. Their failure normally started in a corner by separation of the walls from the

domed roof. In some region the ground shaking was so severe that the abode houses were turned into their original sun-dried bricks.

Figure 4. Heavy walls-thickness of wall in some adobe houses is around 1 m

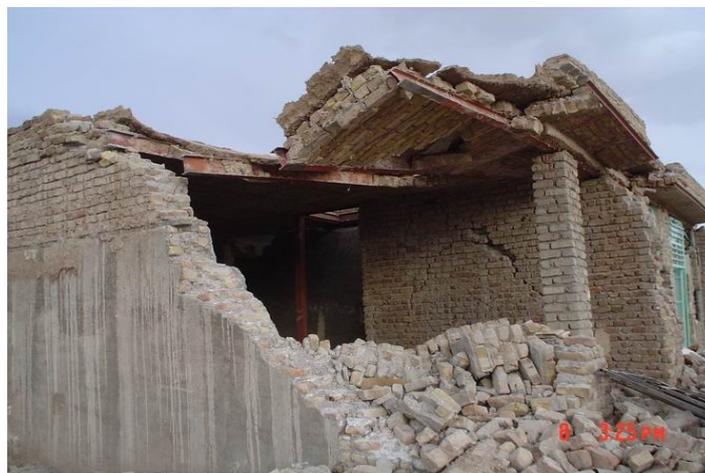
Masonry buildings are the second most common type of buildings in the earthquake-affected area. They normally consist of brick walls with shallow Jack arch roofs supported by steel I shaped beams which is discussed before. The mortar used in these buildings is sand-lime-cement, or sometimes sand-cement. The performance of un-reinforced masonry buildings which lack tie beam or jack arch tie rods was not so better than adobe buildings. The common modes of failure of these buildings were shear failure of walls, separation of walls from the roof, and separation of roof beams from each other (Figure 5). In most cases the steel beams of the roof were not braced together by steel bars or joists. As a result, dropping of the bricks between them during the earthquake could be expected.

Figure 5. Shear failure of walls, separation of walls from the roof, and separation of roof beams from each other are observed in typical brick buildings

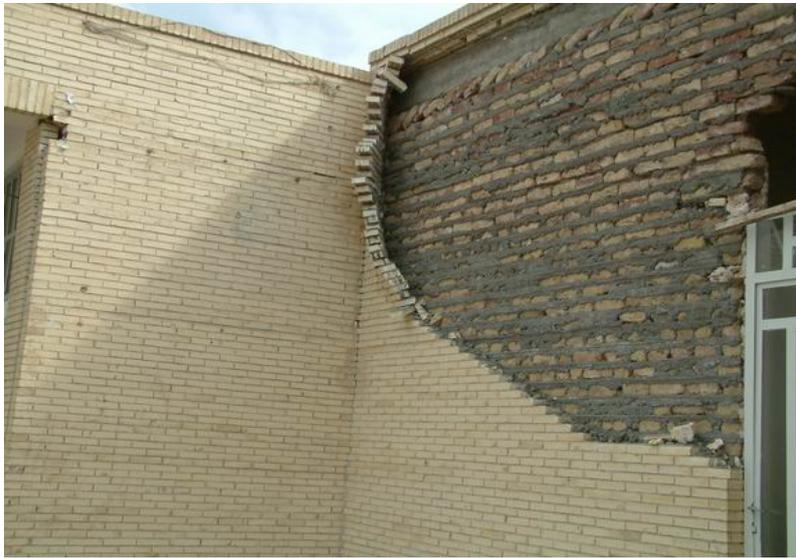
A number of reinforced masonry buildings, with vertical and horizontal reinforcing tie beams, were recently built in the city. The performance of these structures was good and in many cases saved the lives of their inhabitants (Figure 6). In many cases the material used for tie beams or their execution quality was so bad that the element hardly could resist earthquake. It is found that the philosophy of the tie beam to protect the unity and integrity of the walls was not understood well. For example in some cases the bond between tie beams at the wall corners has poor conditions. However, wherever the tie beam had a relatively good condition, the performance was satisfactory.

Figure 6. An example of reinforced brick buildings in the earthquake-affected area with a relatively good performance

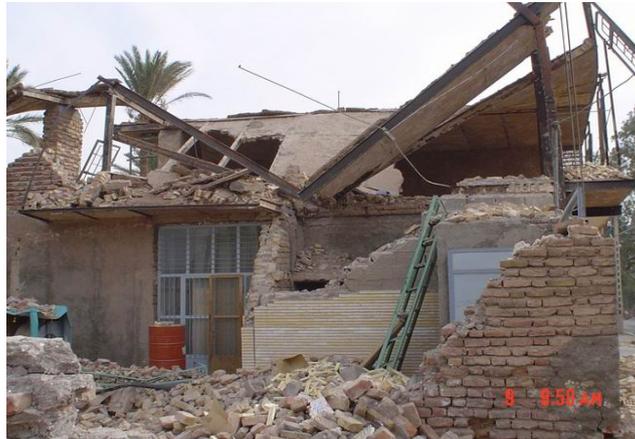
Many modern residential and office buildings in Bam are steel building structures that can be divided into two groups. The first group includes buildings with steel internal columns, load-bearing external brick walls, and roofs, often, made of shallow Jack arches with steel I-beams. The performance of this type of construction as a sort of un-reinforced masonry structure was very poor. The flexible steel columns tended to displace much more than the rigid external walls resulting in inclining of the steel columns and mostly the collapse of the whole structure (Figure 7). This earthquake clearly demonstrated that the combination of relatively rigid load-bearing external brick walls and flexible internal steel columns is very hazardous. This type of structure is not limited to Bam, and it can be easily observed in most of the cities in the country.

Figure 7. First group of steel buildings, combination of steel internal columns and load-bearing external brick-walls

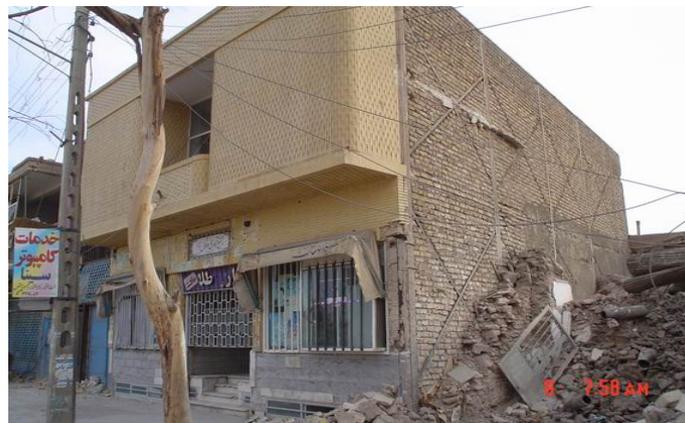
The second group of steel buildings consists of steel frames just in one direction with bracing in one or two directions. They are actually designed for some horizontal forces. The performance of this type of construction was generally satisfactory (Figure 8). Exceptions are made when the bracing were placed non-symmetrically or incorrectly. In these cases, the infill or curtain walls usually experienced severe damage; i.e. due to the weakness of the lateral load bearing element, the infill or curtain walls had been activated during the earthquake and resisted the applied loads resulting in their severe damage. In braced steel structures, the bracing and their connections had different defects like insufficient cross section area, insufficient connection plate, improper connection execution, and so on. Therefore most of them could not effectively resist applied loads. In fact this earthquake proved that use of steel beams and columns in building structures without observing proper seismic code provisions for earthquake resistance showed no improvement over non-engineered buildings.

Figure 8. Steel building with good performance during the Bam 26.12.2003 earthquake

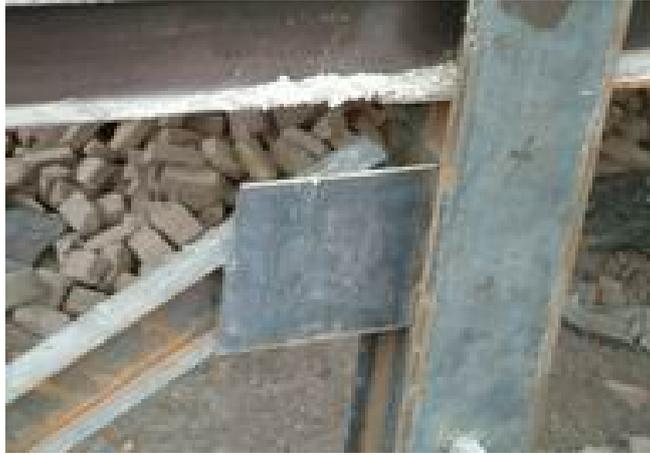
Figure 9. Incorrectly bracing with single I shaped brace only connected to the column

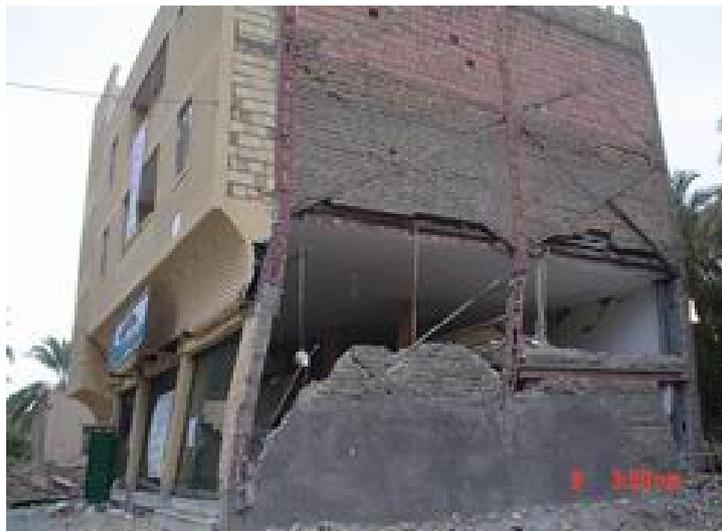
Figure 10. Unacceptable bracing system where the cross-section of bracing member is insufficient

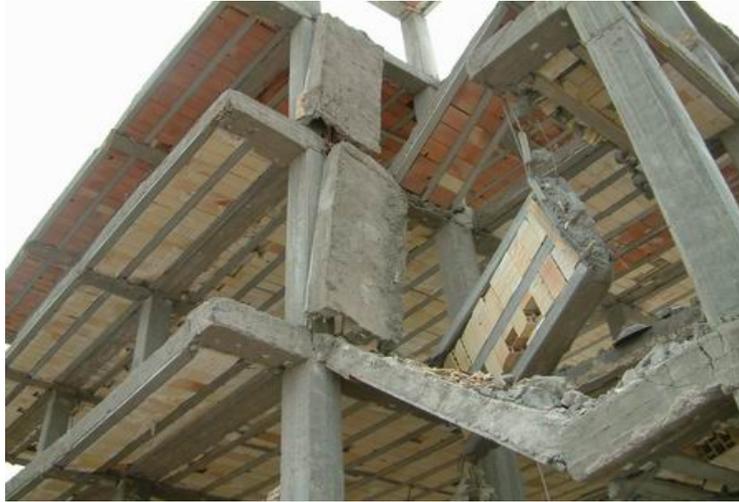
- A. Poor performance of stairs as shown in Figure11.
- B. Poor quality of concrete.

Figure 11. Poor performance of stairs in reinforced concrete structures

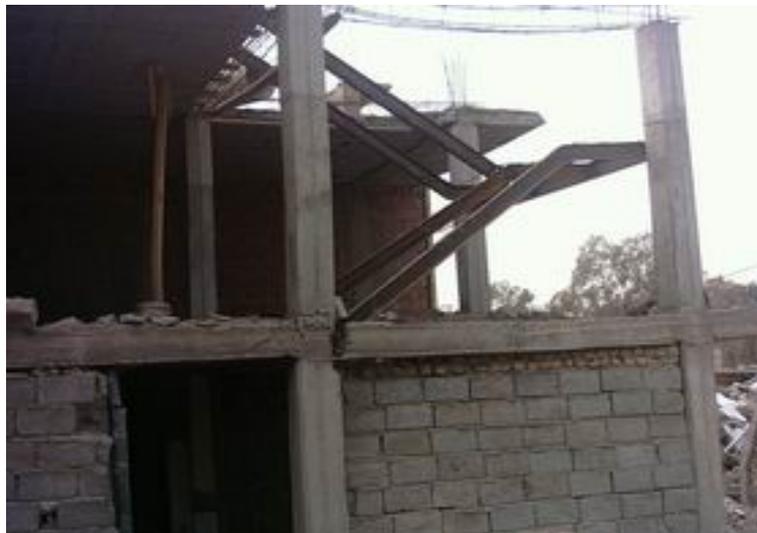
- A. Lack of homogeneity between the structural components. For example in one case in a reinforced concrete structure, steel stair case was used (Figure12).

Figure 12. Use of steel stair in a reinforced concrete structure

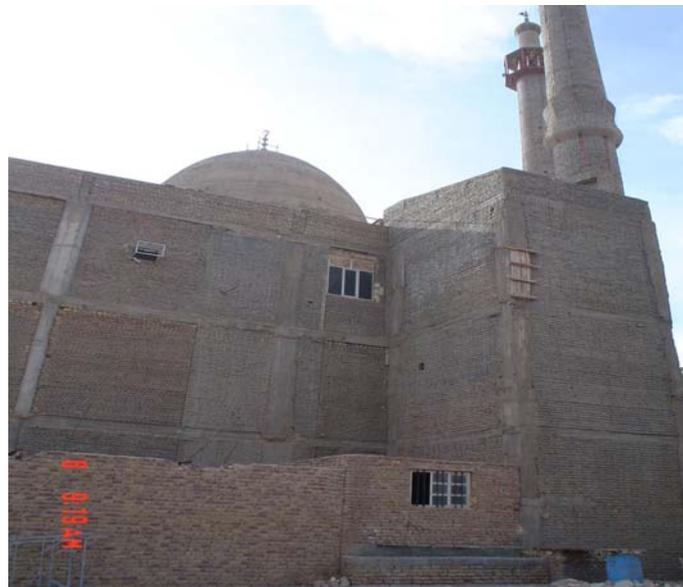
There are some notable structures other than buildings in the area from which the most important are a reinforced concrete mosque; an elevated reinforced concrete water tank tower and multi span Reinforced Concrete Bridge. As a whole, all of them had a satisfactory performance and do not sustain any significant damage. In the case of the mosque, it has a three dimensional dome and it is very difficult to find a crack created from the earthquake and all the walls remained undamaged (Figure13). Some researchers such as Adeli [5] believe that due to the three dimensional behavior of dome, the structure is treated rigidly during the earthquake. Also field investigations showed that the structural elements (beams and columns) had adequate steel bars and cross sections. The concrete and brick infill walls were observed to have good conditions. It is believed that the infill walls greatly increased the stiffness of the structure in both directions.

Figure 13. A reinforced concrete mosque after the earthquake which had a satisfactory performance

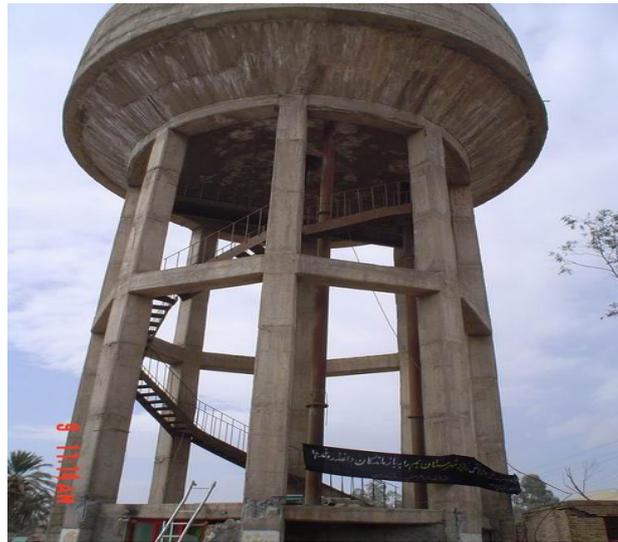
The other important structure is an elevated reinforced concrete water tank tower with approximately 20m in height and 350m³ in capacity which can be seen in Figures 14 and 15.

Figure 14. The elevated reinforced concrete water tank tower, where some cracks in the structural joints can be seen but the general performance is satisfactory.

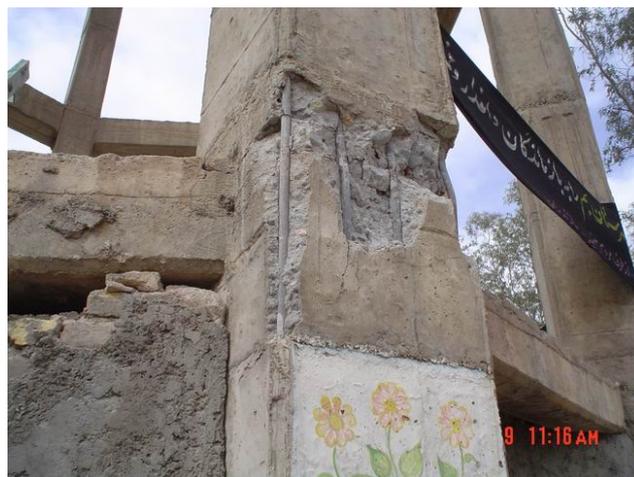
According to Figure15, the general performance of the structure was good but as shown in Figure15, some joints cracked so that the steel bars can be seen. As a matter of fact the only observed defect in this structure was improper reinforcement detailing. Investigations showed that the used steel rebars in the structure were round ones to which the cracks to some extent can be related. In addition, one will be surprised knowing that the columns are not reinforced with ties (at least in the joints). It is believed that the cracks in the joints to a great extent are related to the lack of ties in the joints.

Figure 15. Clos-up view of the cracks in the structural joints of the elevated reinforced concrete water tank tower (note the rebars with no threads).

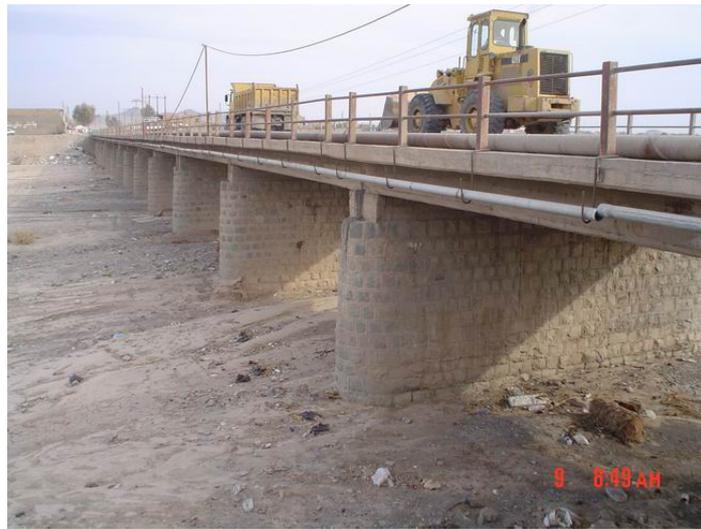
The other important structure in the area is a reinforced concrete bridge having piers lined by stone to resist against the river flow and its probable erosion (Figure 16). Like the mosque and the water tank tower, the mentioned bridge had good conditions being under service after the earthquake. Some parts of abutments cracked slightly, but there was no lateral displacement. Some spans got separated about 3 centimeters from the abutments (Figure17). As a result we can conclude that this bridge withstood the intense earthquake approximately without significant damage.

Figure 16. General view of the multi spans Reinforced Concrete Bridge after the earthquake which is in good condition and of course under service.

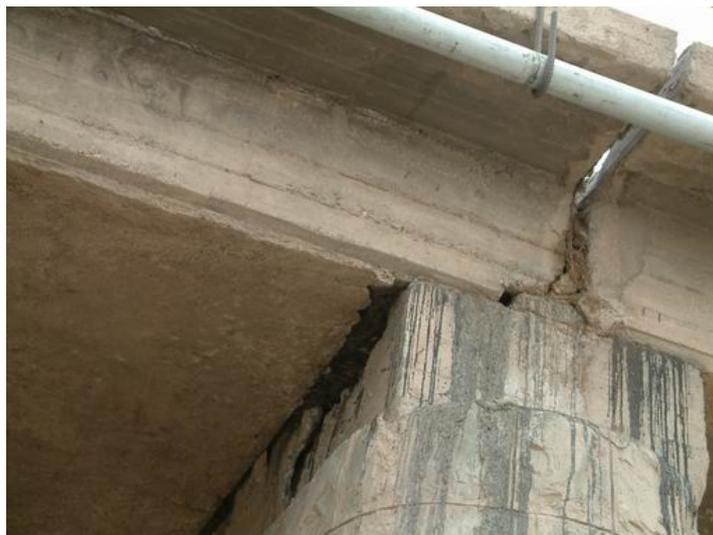
Figure 17. Separation of bridge Spans from the abutment
