Technical Note

Construction of relief wells under artesian flow conditions at dam toes: engineering experiences from Karkheh earth dam, IranM. Heidarzadeh^{1,*}, A. A. Mirghasemi², H. Niroomand³

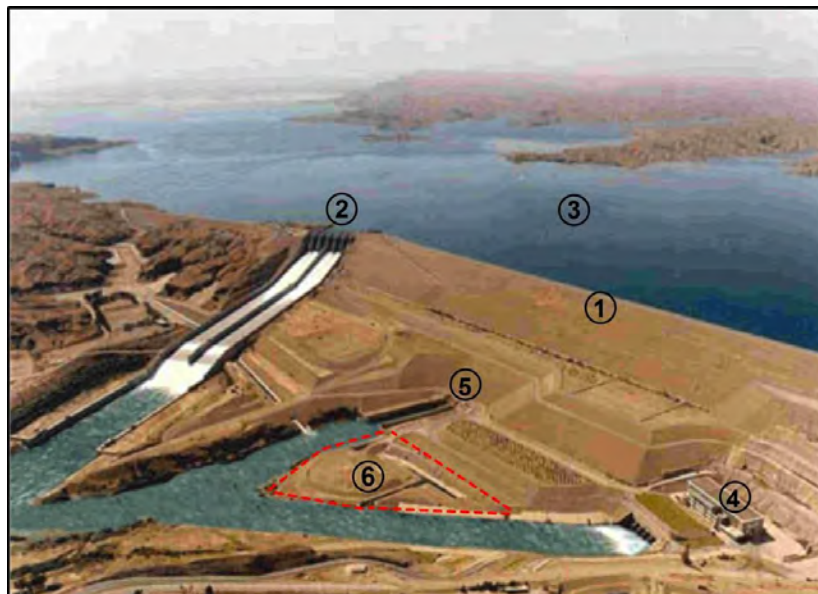
Fig. 1 General plan of the Karkheh dam project. The numbers represent: 1, dam crest; 2, spillway; 3, reservoir; 4, powerhouse; 5, diversion culverts; and 6, the location of the new relief wells at dam toe (the red-dashed polygon)

Karkheh, an earth and rockfill dam with the height and length of 127 and 3030 m respectively, is the largest dam in Iran in view of reservoir capacity (Fig. 1). The capacity of

the Karkheh River, a power house with total capacity of 400 MW at the left abutment and a gate-controlled chute-type spillway (Fig. 1). The Karkheh Dam provides about 4 billion cubic meter of regulated water to irrigate 320,000 hectares of downstream farmlands.

Considering the presence of an artesian aquifer in the foundation of the Karkheh dam and associated probable uplift pressure in the future, some relief wells were constructed in the downstream toe of the dam during its construction (1995-2001) (red-dashed polygon in Fig. 1). These well penetrated from 10 to 20 m into the artesian aquifer with spacing of about 20 m from each other. In total, 19 relief wells with the diameter of 2 or 3 inches were constructed to relieve part of the excess uplift pressure of the artesian aquifer and consequently to improve the safety factor of the area against instability (Mahab Ghodss Engineers 1998 [10]). After the reservoir impoundment in February 2001, these wells discharged water from the confined aquifer and relieved the existing hydrostatic pressure. Due to some shortcomings in the installation of these wells, and improper estimation of the foundation permeability (Mirghasemi and Pakzad 2005 [11]), they were not able to effectively discharge water from the confined aquifer. At the highest reservoir level, the total amount of water discharge from 19 relief wells was about 35 lit/sec which was a disappointing record.

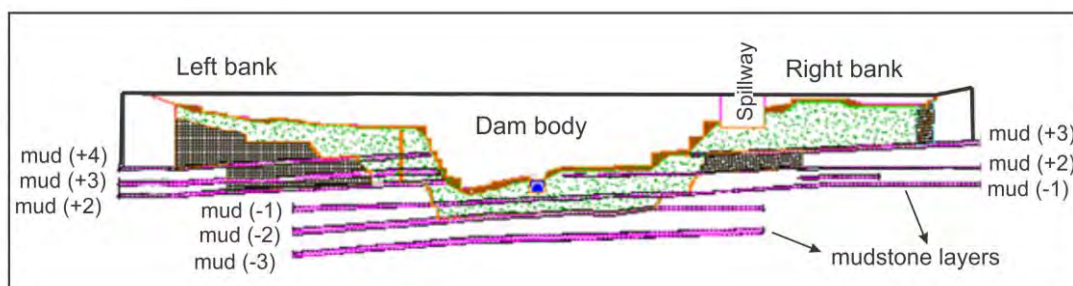
Fig. 2 Karkheh dam longitudinal section showing dam geological layers. Dotted and hatched areas represent the extensions of the dam's old and new plastic-concrete cutoff walls. The figure is exaggerated in the vertical direction

dam is responsible for the establishment of high uplift pressure at the downstream toe of the dam. Karkheh dam is placed on a horizontally-stratified foundation which is a combination of permeable conglomerate and relatively impervious mudstone layers (Fig. 2). The overall permeability of the conglomerate is estimated to be in the relatively high range of about $4-9 \times 10^{-4}$ m/s. The impervious horizontal mudstone layers stratify the conglomerate with 3 to 9 m thickness and a permeability of about 10^{-7} to 10^{-10} m/s, which are bedded horizontally in the area of the project (Fig. 2). In Fig. 2, the mudstone layers are numbered due to the river bed level so that the layers located above and below the river bed level are entitled with plus and minus numbers, respectively.

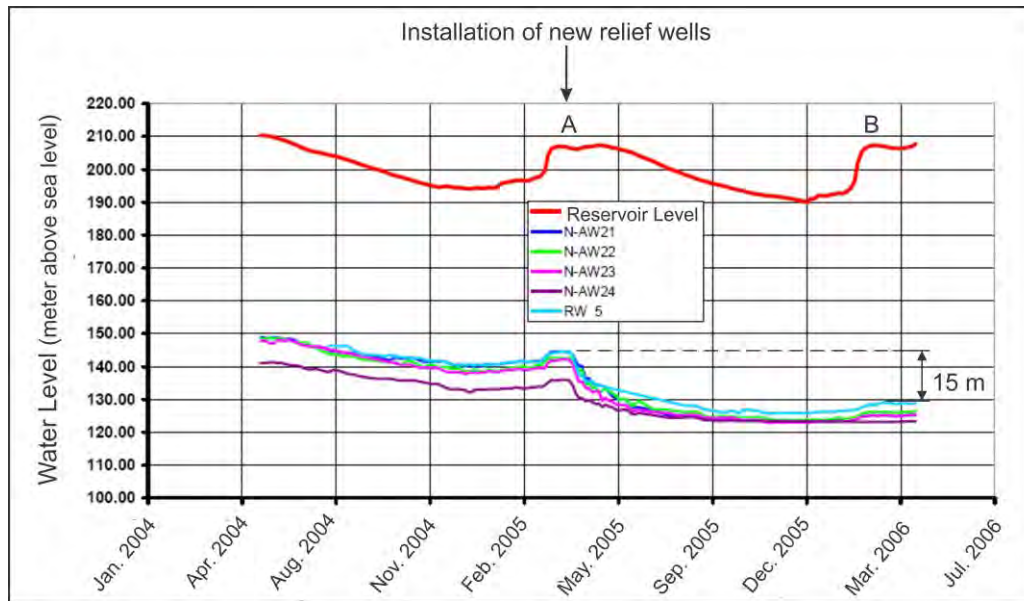
Fig. 3 Water level fluctuations for the conglomerate layer between mudstone layers (-3) and (-2) in some observational wells, installed in the downstream of the Karkheh dam. The thick-red line at the top of the figure shows reservoir water level

To monitor the performance of these relief wells and to determine their precise effect on the reduction of the uplift pressure, some observational wells were installed in the artesian aquifer. Figure 3 presents fluctuations of water level in the conglomerate layer between mud (-3) and mud (-2) at 5 observational wells, installed at the downstream of the dam. These observational wells were installed at the dam toe in the area shown with the red-dashed polygon in Fig. 1. As can be seen, for the reservoir water level of around 200 m (in September 2004, Fig. 3), the water level in the observational wells was around 140 m. Since the elevation of the dam toe is around 120 m, the water levels in the observational wells produce an uplift pressure of around 20 m (i.e., 2 atm) to the dam toe. For the reservoir water level of 210 m (in April 2004, Fig. 3), the hydrostatic pressure to the dam toe is about 30 m above the ground level (Fig. 3). Such high uplift pressures decrease the safety factor of the dam toe to the unsafe value of 0.95 (Mahab Ghodss Engineers 2004 [5]). Therefore, installation of new relief wells was necessary to relieve part of these excessive uplift pressures and to assure the stability of the dam toe.

wells was used (Fig. 3). Based on these observational wells, the water surface was estimated about 15-20 m above the ground surface at different locations in the region shown by dashed-red polygon in Fig. 1. For controlling artesian flow, a 20-inch diameter vertical pipe with a length of 15-20 m was attached to the top of the 20-inch casing (Fig. 5). The artesian water flow was stopped by adding this long vertical pipe to the top of the well. After the artesian water flow was stopped, filter materials were placed and the interface of the mudstone layer (-2) was blocked (Figs. 4-5).

The best way to evaluate the performance of new relief wells in reducing the regional uplift pressure is measurements from downstream observational wells (Fig. 3). As shown by an arrow in Fig. 3, new relief wells started to be installed around March 2005 (point A in Fig. 3) where the water elevation in the observational wells was about 145 m. Reservoir water level was at 208 m above sea level at this time. It is clear that to evaluate the performance of new relief wells, different water elevations in the observational wells should be compared with each other at the same reservoir water level. Around one year after the installation of new relief wells (i.e., February 2006), the reservoir water level reached the same level of 208 m (point B in Fig. 3). It can be seen that at point B, the water elevation in observational wells decreased to the value of 130 m suggesting a 15-m decrease in regional uplift pressure. This shows that the new relief wells were successful in releasing part of the extreme uplift pressures. Table 1 presents the amount of water discharge of each of the newly-installed large-diameter relief wells. The discharge from each newly-installed small-diameter well was around 10 lit/s. From Table 1 and taking into consideration the discharge from small-diameter wells, the total water discharge of the new relief wells is about 900 lit/s. The drainage discharge from all old relief wells (9 wells- Fig. 6) was around 35 lit/s.

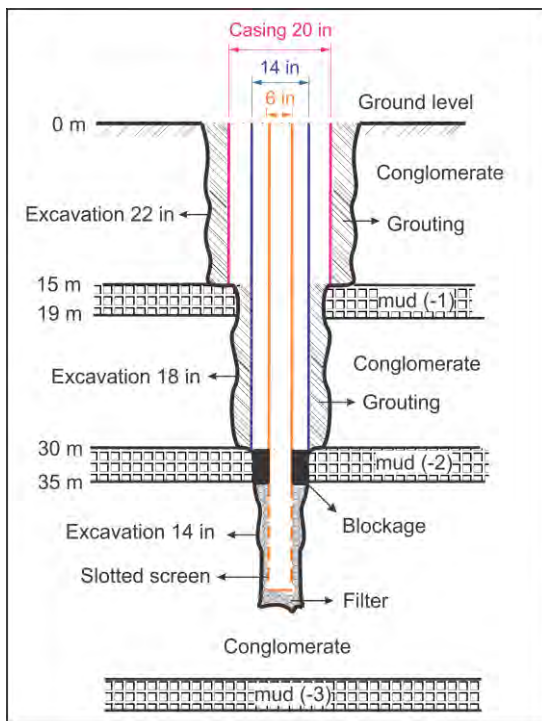
Fig. 4 Sketch showing the details of the telescopic well used for the installation of new relief wells at the toe of the Karkheh dam

The method used in Karkheh dam is based on a telescopic drilling technique in which drilling diameter decreases by depth. This method, which is pretty old and is popular in oil industry, presented various advantages in our practice which is discussed later in the article. Figure 4 shows the details of the telescopic well used for the installation of new relief wells at the Karkheh dam toe.

In this technique, first, using the direct rotary method, the well was drilled down to a few meters below the top of the mudstone layer No. (-1) with a diameter of 22 inches. Then, a 20-inch diameter casing was installed to 1 meter below the top of the mudstone layer No. (-1) (Fig. 4). Sand backfill having grade size in the range of 0-5 mm was placed in the space between the borehole wall and the casing. It can be noted that a one-inch narrow pipe was attached to the casing during its installation. This narrow pipe was used later to inject grouting materials to the sand backfill using low pressures in the range of 1-5 kg/cm². The grouting materials were a combination of water, cement with the water/cement ratio of 1/2, and conbex-100 to the amount of 0.5 percent by volume of cement. Then, the well construction was stopped for about 3 days to

The next step was installation of a 14-inch casing down to 1 meter below the top of mud (-2) (Fig. 4). The boring diameter for this casing was 18 inches (Fig. 4). Similar to the first step, the conglomerate layer confined between mud layers (-1) and (-2) was water proofed using grouting. This stage of water proofing was more challenging because the aquifer located in the bottom of mud (-2) was artesian.

The most challenging task during the installation of new relief wells was cutting of the mudstone no. (-2) in order to penetrate into the artesian aquifer (Fig. 4). As mentioned above, the conglomerate layer confined between mudstone layers (-3) and (-2) was under extreme artesian pressure of around 20-30 m above the ground level. Therefore, it was necessary to control the existing artesian conditions in order to be able to block the aquifer and to place the filter material (Fig. 4). Before proceeding this step, we needed to estimate the amount of existing uplift pressure in the artesian aquifer and consequently to calculate the potentiometric head of the water. For this, information obtained from observational

To stop uncontrolled artesian flow encountered during the installation of the first observational well, at first, the well was filled with a large amount of surcharge consisting of concrete, gravel and clay. However, it was not successful after two days of filling and artesian flow continued to wash out soil particles. At this stage, we noticed that the artesian pressure for the conglomerate layer between mudstones (-3) and (-2) is far more than our previous expectations. In fact, this incident was an opportunity to have a realistic understanding of the concentrated and high uplift pressure at the Karkheh dam toe. Finally, we reached the idea that the well needs to be re-drilled and its walls should be grouted down to the mudstone (-2). In this process, about 20 tons of cement was grouted along with the placement of 10 m³ of sand (0-20 mm). In fact, the idea for the installation of new relief wells using the method shown in Fig. 4 was the outcome of our challenges with the failure of this observational well.

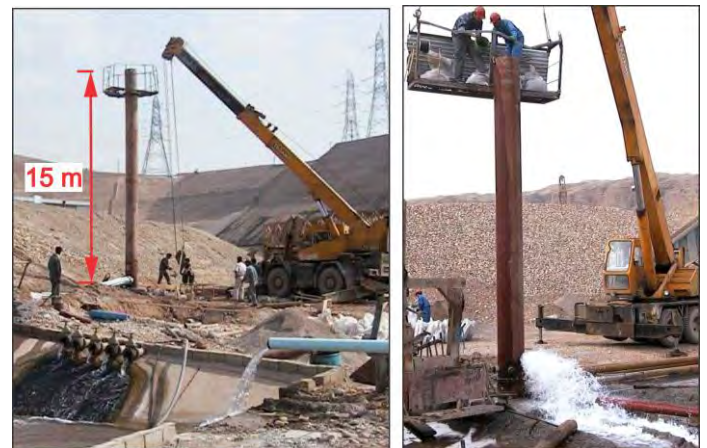
Fig. 5 (Left): controlling the artesian flows by adding long vertical pipes at the top of the relief wells at the Karkheh dam site. (Right): placing filter materials after controlling of the artesian flow

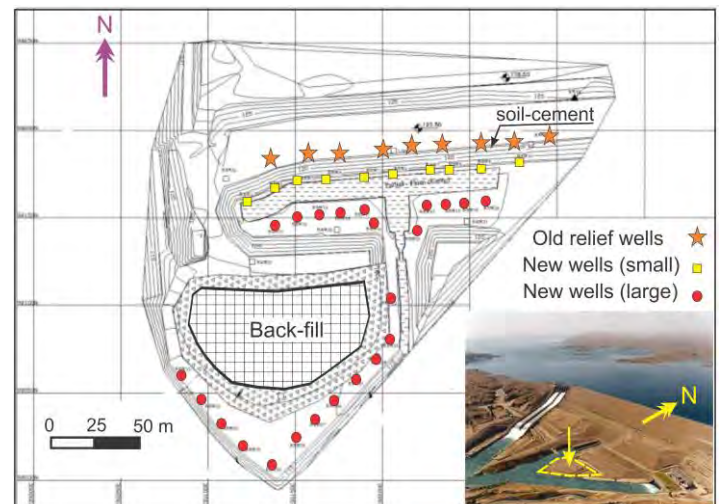
Fig. 6 Location and arrangement of the old and new relief wells installed at the downstream toe of the Karkheh dam

Using this technique, 33 new relief wells were installed at the toe of the dam which are shown in Fig. 6. As shown in Fig. 6, new relief wells are of two types: 10 wells with small diameter and 23 wells with a larger diameter of 6 in. The small-diameter wells are installed at the northern part of the dam toe (Fig. 6) where construction of larger-diameter wells was not possible due to some limitations. In addition to relief well installation, back filling of the dam toe also was considered to increase the safety factor of the area which is shown in Fig. 6.

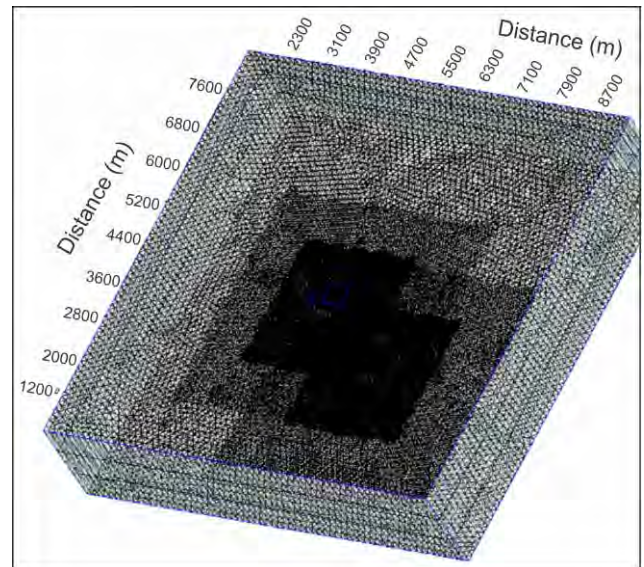
Fig. 7 Computational 3D mesh used for modeling the artesian aquifer confined between mudstone layers (-3) and (-2) at the Karkheh dam toe

In our model, a rectangular domain having dimension of 8 km × 8 km was modeled using 70876 nodes and 105516 6-noded triangular-prismatic 3D elements. We assumed the steady state seepage condition for our modeling (Fig. 7). The domain length of 8 km seems enough because the mudstone layer (-2) crosses the reservoir at the distance of 4 km from dam axis.

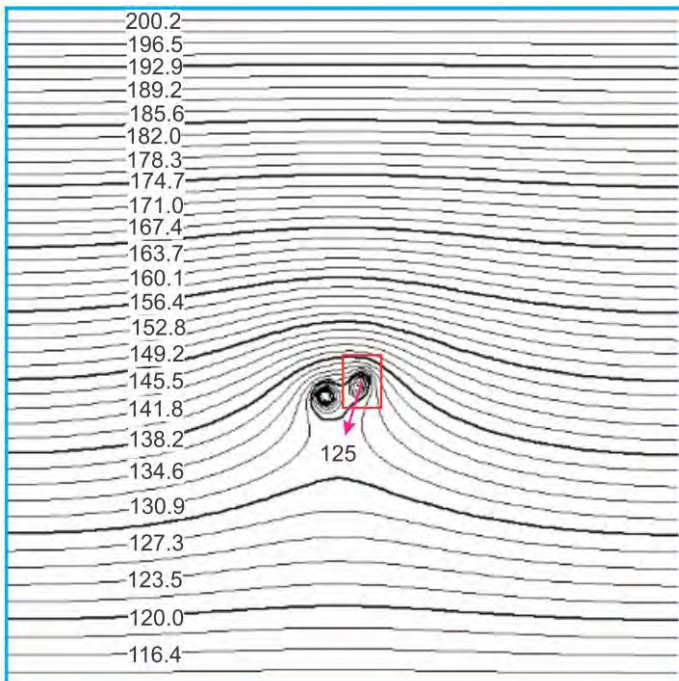
Fig. 8 Results of 3D seepage simulations for the artesian aquifer confined between mudstone layers (-3) and (-2) at the Karkheh dam toe. The lines represent iso-potential lines. The numbers are water head in meter above sea level. The red rectangle shows the dam toe where the new relief wells were installed

This calibration resulted in the horizontal permeability of 1.6×10^{-3} m/s. Figure 8 shows the iso-potential lines for the modeled region indicating that the water head significantly decreased at the dam toe (red-rectangle in Fig. 8) due to the installation of the new relief wells. According to Fig. 8, the modeled water level at the downstream toe is around 125 m which is close to the observed values (Fig. 8 and Table 2). In other words, the

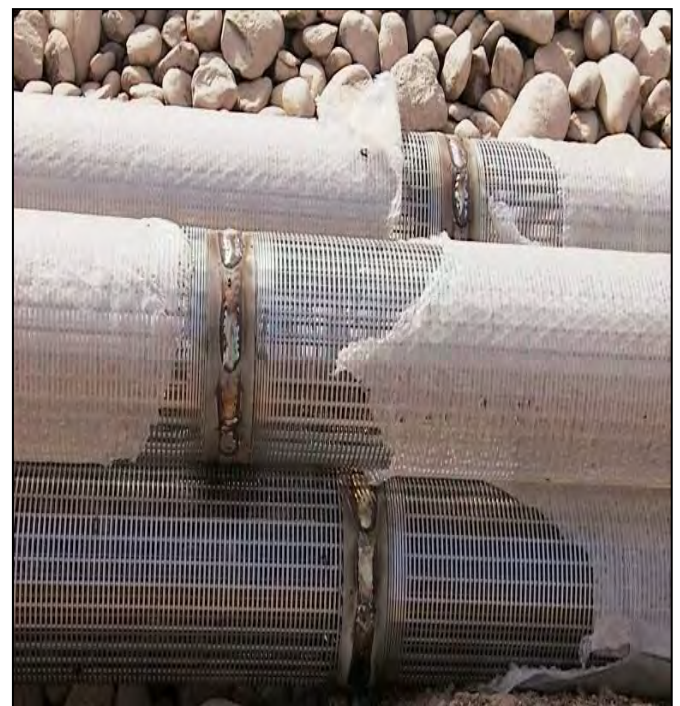
Fig. 9 Picture showing the arrangement and size of the well screens used for the new relief wells at the Karkheh dam

Our experience suggests that the arrangement of the openings and their size are of vital importance for the proper function of the wells. As discussed above, one of the main shortcomings of the old wells was inappropriate opening arrangement and size. For the new wells, we changed the arrangement of the screens and used a regular shape for them (Fig. 9). In addition, we significantly increased the ratio of opening area to the total well area. In fact, there is no limit for the maximum screen area as long as the filter materials are prevented from entering the well. Therefore, we maximized the opening area of the wells (Fig. 9).
