International Journal of Civil Engineering (2019) 17:859–869
https://doi.org/10.1007/s40999-018-0370-4

Construction and performance of the Karkheh dam complementary cut-off wall: an innovative engineering solution

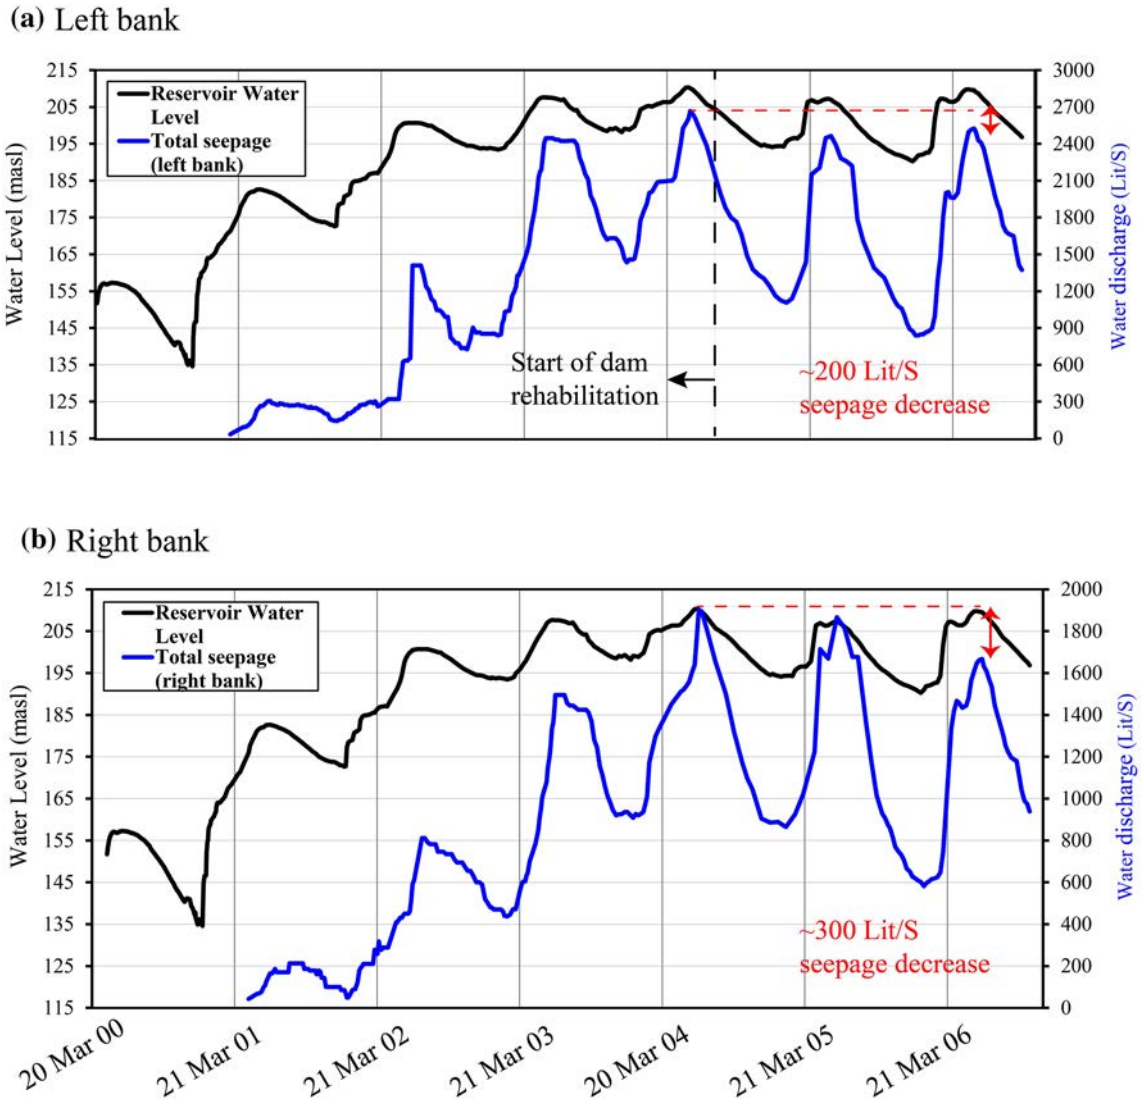
Fig. 3 Seepage through the Karkheh dam's left and right banks. The start time of the dam rehabilitation and the effect of remedial works on seepage control are shown in this figure

was observed through the dam foundation and abutments (Fig. 3). Figure 3 shows that the total seepage volumes through the left and right banks of the dam were 2700 and 1900 Lit/S, respectively, at the maximum water level of 210.5 masl. The high hydraulic gradient values were also a significant concern as they were around 0.2 at some parts of the dam. Such unexpected excessive water seepage was attributed mostly to the inaccurate estimate of the dam foundation permeability coefficient [8].

A series of remedial measures were implemented to increase the safety factor of the dam, including extension of the cut-off wall both at the right and left abutments, filling of different valleys around the dam abutments [11], installation of new relief wells at the dam toe [7], and grouting of dam foundation through access galleries [3, 4]. A core purpose for these remedial measures was to decrease the hydraulic gradients of the seepage flows. The most important feature of these measures was the extension of the existing cut-off wall at the left and right banks. Four complementary cut-off walls were constructed and were connected to the main (old) cut-off wall which are:

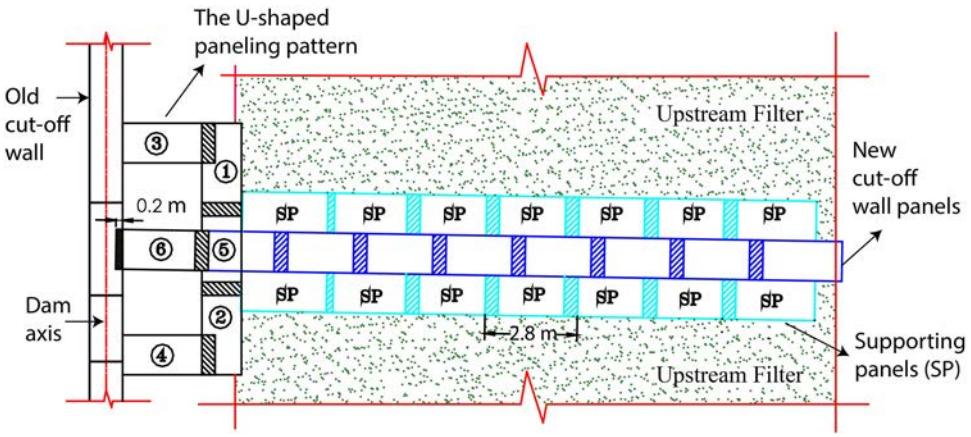
Fig. 6 The U-shaped paneling pattern to connect the new cut-off wall to the old wall as well as the supporting panels (SP) (cyan-colored panels) at both sides of the new cut-off wall panels (blue-colored panels). Dimensions are in meters

decreases the hydrostatic pressure on the final connecting panel (i.e., panel No. 6) as well as it offers additional safety to the system in case the final connecting panel fails for whatever reason.

The panel No.6 plays a key role in our U-shaped pattern. Because the construction of this panel requires cutting some part of the old cut-off wall, a meticulous procedure was necessary for its construction. In this context, the excavation rate for the panel No. 6 was reduced. The drilling fluid used for excavation of the connecting panel was heavier than ordinary drilling fluids to prevent possible slurry loss, which could have negative consequences. In addition, the mechanical properties of the plastic concrete were carefully monitored during construction of the panel No. 6 to ensure the high quality of the materials.

b. To approach the old cut-off wall, a U-shaped paneling pattern was designed (Fig. 6). The U-shaped pattern is consisting of six panels: three panels perpendicular to the old cut-off wall's axis and the others parallel to it. The purpose of this U-shaped pattern was to provide an area of balanced hydrostatic water head at depth for construction of the connecting panel (i.e., panel No. 6 in Fig. 6). In this method, at first the panels No. 1 and 2 were constructed parallel to the old cut-off wall. Then, panels No. 3 and 4 were made in normal direction to the old wall's axis. After performing panel No. 5, the connecting panel (i.e., panel No. 6) was constructed with 20 cm overlap with the old wall. It was believed that by performing panels No. 1 to 5, the hydrostatic pressure inside the U-shaped space would have been significantly decreased; hence, providing a safe zone for making the connecting panel. The advantages of the U-shaped pattern over a line pattern lie in the facts that it significantly

The above measures were applied to stop slurry loss at panel No. 4 (Fig. 6). Results showed that the third measure, i.e., application of a grout mix, was the most effective one. To stop the slurry loss in the panel No. 4, at first a relatively viscose drilling fluid, having density of about 1.14 g/cm^3, and Marsh viscosity of about 37 s was used which was not successful. Then, as a second try, we added materials such as a combination of clay and sand to the panel. This method showed satisfactory results at the beginning and was capable of reducing the rate of slurry loss from 100 to 10 cm/min. However, gradually the slurry loss rate increased again and reached the high rate of 126 cm/min proving that the second method also was not efficient in slurry loss control. Finally, the method of adding a grout mix to the panel was examined. We designed a cement-based grout mix whose components were: 150 kg of cement and 160 kg of bentonite and water was used. Such a grout mix stopped the slurry loss completely. Grouting was performed using a diesel pump providing pressure of around 5 bar which guided grouting materials into the grouting holes spaced 1–2 m from each other.

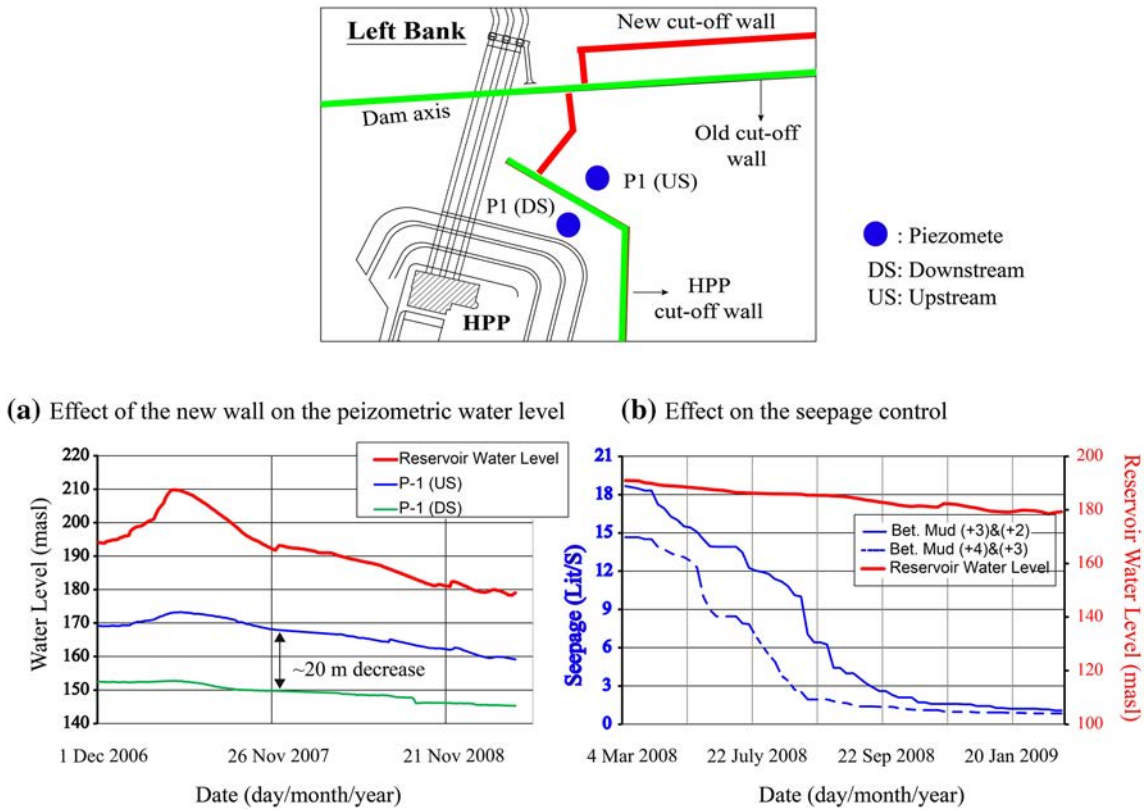
Fig. 8 Effects of the construction of the new cut-off wall segments 1 (left bank) and 2 (around HPP) on the seepage control

0 + 850, 10 m water elevation reduction was observed at the piezometers installed downstream of the new cut-off wall, between mud (+ 2) and mud (+ 3). Additionally, the hydraulic gradient was reduced from 0.154 to 0.13 between mud (+ 2) and mud (+ 4). The total water seepage was reduced around 200 Lit/S (Fig. 3). The piezometers installed at the opposite side of the HPP wall, P1 (US) and P1 (DS) in Fig. 8a, showed ~ 20 m of water level decrease after the construction of new cat-off wall 3. Figure 8b reveals a significant decrease in water seepage through the left bank following the construction of this new wall (segments 1 and 2).

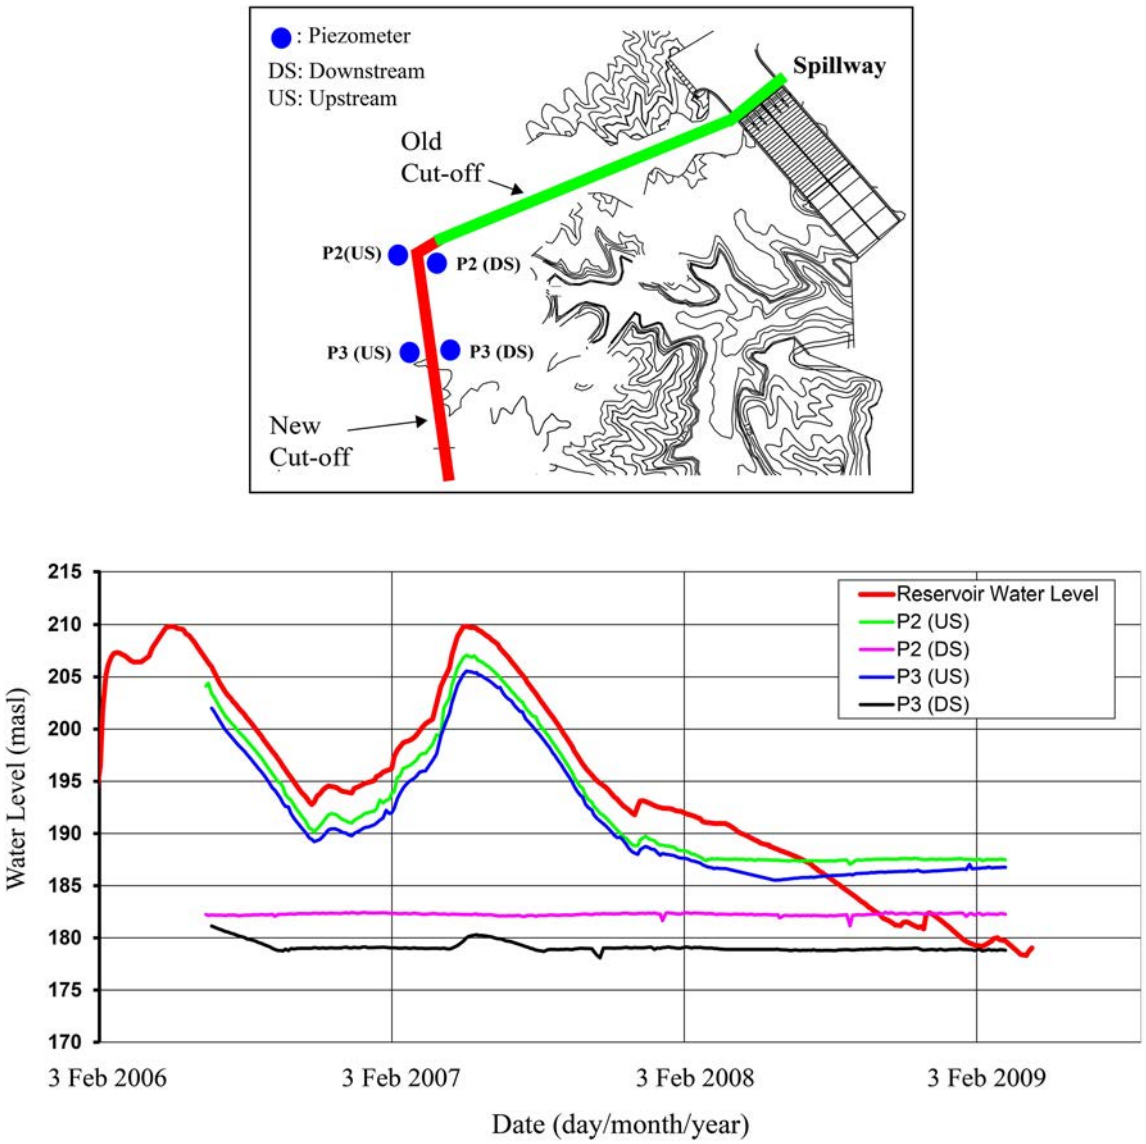
Fig. 9 Effects of the construction of the new cut-off wall segments 3 (right bank) on the seepage control

- The new cut-off wall in the right bank (complementary cut-off wall segment-3): After the construction of around half of this wall, the seepage amount at the right bank is reduced about 25% (300 Lit/S, Fig. 3), and the hydraulic gradient was reduced from 0.2 to 0.095. Figure 9 shows that the piezometers installed at the downstream of the complementary wall, P2 (DS) and P3 (DS) in Fig. 9, have flat water levels which indicate these observation wells receive no seepage from the dam's reservoir. In other words, the downstream side of the wall is almost dry.
- The new cut-off wall around spillway (complementary cut-off wall segment-4): Data from piezometers installed at both sides of the new cut-off wall around spillway, P4 and P5 in Fig. 10, showed water levels decreased between 18–22 m as a result of the new wall construction.
