Field Surveys and Numerical Simulation of the 2018 Typhoon Jebi: Impact of High Waves and Storm Surge in Semi-enclosed Osaka Bay, Japan

Abstract—Typhoon Jebi made landfall in Japan in 2018 and hit Osaka Bay on September 4, causing severe damage to Kansai area, Japan's second largest economical region. We conducted field surveys around the Osaka Bay including the cities of Osaka, Wakayama, Tokushima, Hyogo, and the island of Awaji-shima to evaluate the situation of these areas immediately after Typhoon Jebi struck. Jebi generated high waves over large areas in these regions, and many coasts were substantially damaged by the combined impact of high waves and storm surges. The Jebi storm surge was the highest in the recorded history of Osaka. We used a storm surge–wave coupled model to investigate the impact caused by Jebi. The simulated surge level was validated with real data acquired from three tidal stations, while the wave simulation results were verified with observed data from four wave monitoring stations. The high accuracy of the model demonstrates the usefulness of numerical simulations to estimate the heights of storm surges and wind waves at specific locations, especially

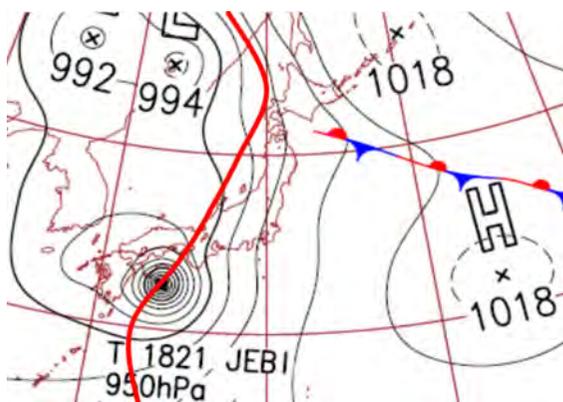
Figure 1

Japan Meteorological Agency's weather map immediately before Jebi made landfall (September 4, 2018, 09:00, Japan Standard Time, UTC + 9) (The red line is Jebi track)

A wind radius of 50-kt was estimated around 220 km (in the longest axis) when Jebi was about to make landfall (Fig. 1). Jebi maintained maximum wind speed of 75–85 kt (139–157 km/h) when it hit Osaka. The sea level pressure during the passage of Jebi over Osaka Bay was of 950–975 hPa. As Typhoon Jebi swept through the Osaka Bay and the south of Honshu Island, it caused heavy rainfall, high

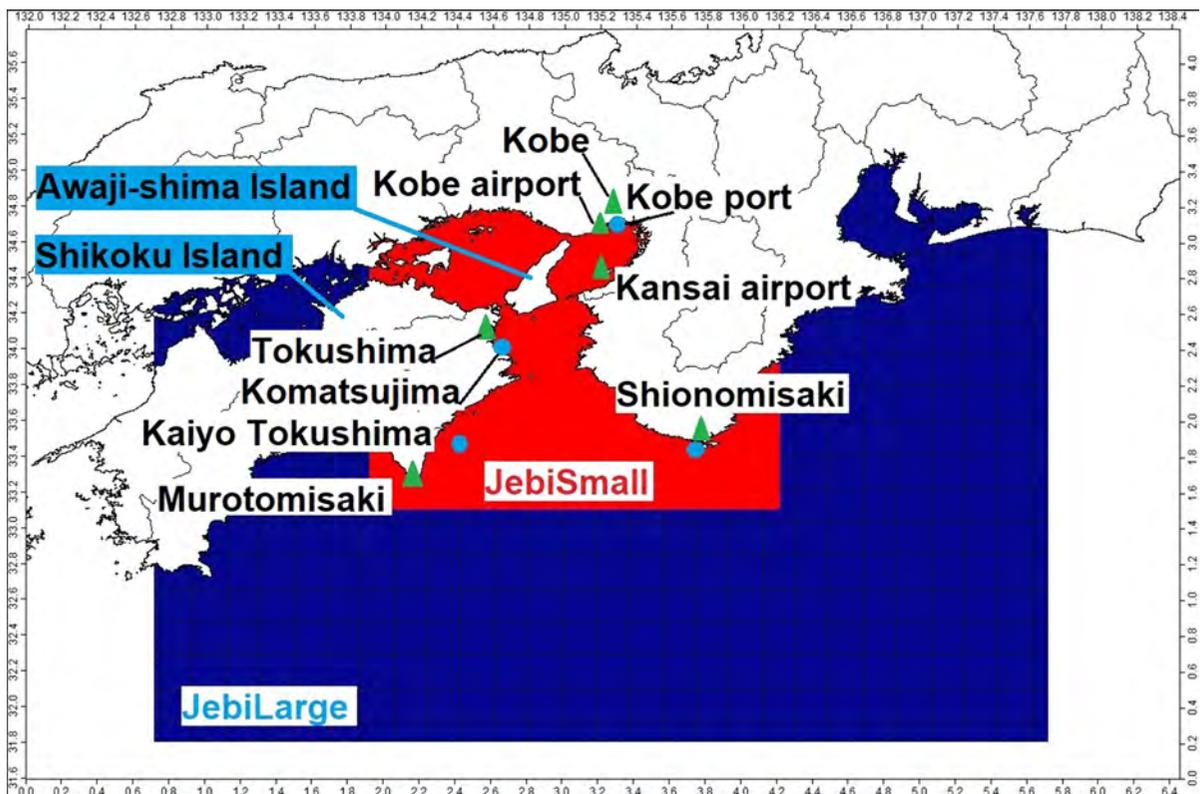
Figure 2

Simulation domains for simulating wind waves during Typhoon Jebi. The indicated locations have wave monitoring stations of the NOWPHAS and wind observation stations from JMA, whose data were used in this study for model verification (circle, wave monitoring station; triangle, wind monitoring station)

The wave simulation was performed by nesting two computational domains. Domain *JebiLarge* (Fig. 2) covers the deep sea outside Japan mainland as parent grid with resolution of $0.02^\circ \times 0.02^\circ$, being used for both hydrodynamic and wave models, whereas domain *JebiSmall* (Fig. 2) includes the inner bay stretch from the Kii Strait to Osaka Bay as nested internal grid with resolution of approximately $500 \text{ m} \times 500 \text{ m}$, being used for detailed wave simulation. The bathymetric data at 500 m intervals and retrieved from the Japan Oceanographic Data Center (JODC) (<http://www.jodc.go.jp/jodcweb/>) was used for both Delft3D-FLOW and Delft3D-WAVE model simulations to incorporate the detailed bathymetry from the study areas. Both models relied on wind fields from the hourly grid point values (GPVs) of numerical weather prediction based on the mesoscale spectral model of the JMA. The forecasting of the mesoscale spectral model is known as the JMA nonhydrostatic model (Saito et al. 2006). The forecast domain is the rectangular area including the entire Japan territory and surrounding area with approximate grid spacing of 5 km (a grid resolution of $0.065^\circ \times 0.05^\circ$ covers the domain from 120°E to 150°E and from 22.4°N to 47.6°N). Data of GPVs are available from the server of the numerical weather prediction/observation data of the JMA (Japan Meteorological Agency. The numerical forecast data/observed data). The data contain many variables including sea-level pressure, surface pressure, and eastward/northward components of wind.

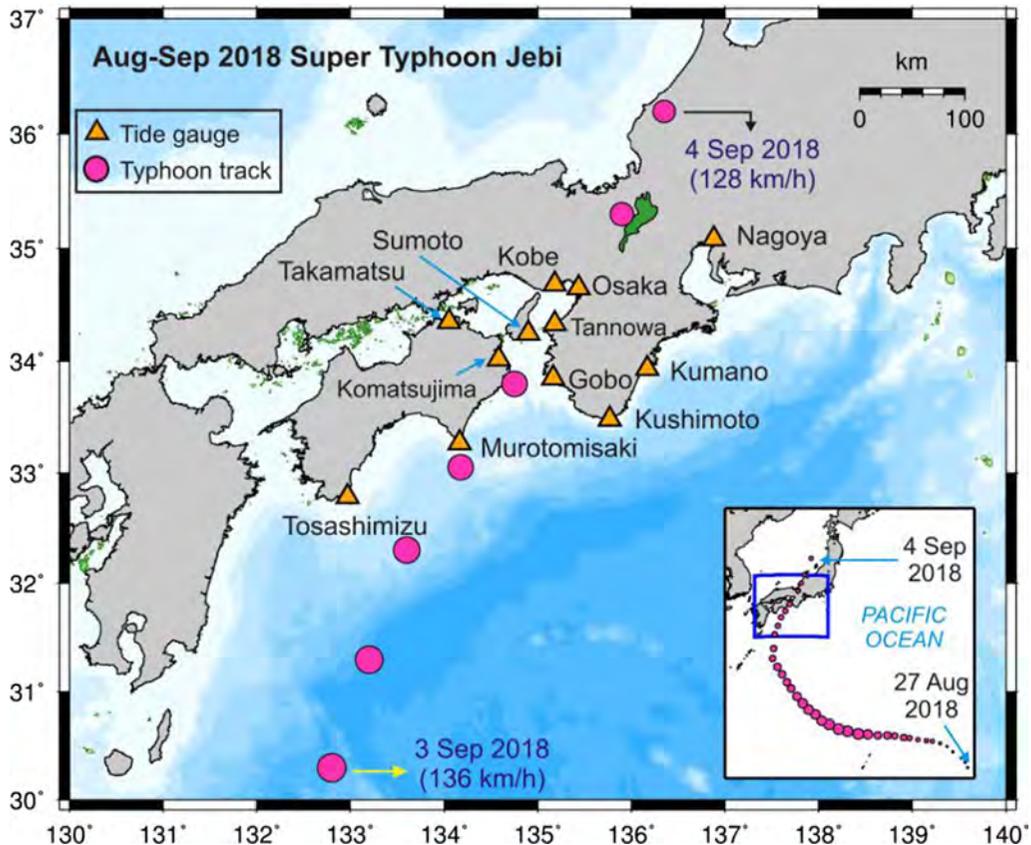
Figure 3

Map of west Japan showing the locations of tide gauge stations (orange triangles) considered in this study and trajectory (pink circles) of Typhoon Jebi from August to September of 2018

We analyzed the sea level data at 12 tide gauge stations along the trajectory of Typhoon Jebi (Fig. 3). The original data were sampled at intervals of 15 s and provided by the JMA. Tidal signals were estimated using the MATLAB Tidal Fitting Toolbox (Grinsted 2008), and sea level references were removed to produce detided waveforms. In addition, we applied a 15 min

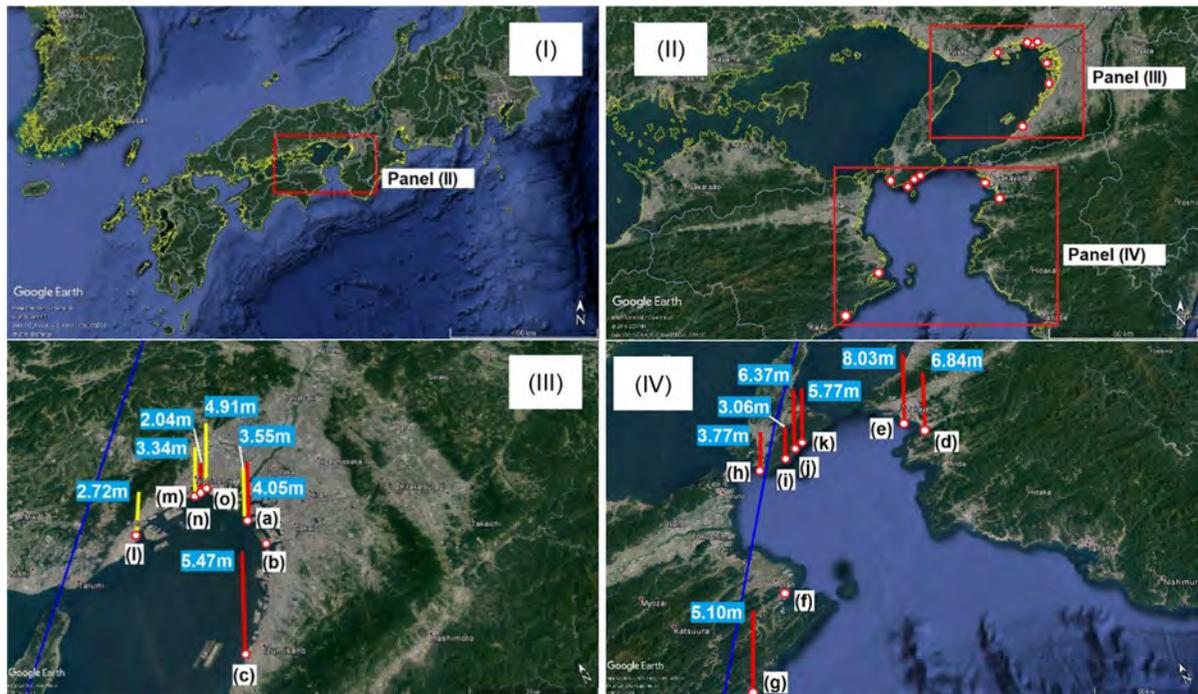
I Large view of field survey area, II location of survey points, III storm surge and overtopping height measurements inside Osaka Bay and IV around Kii Strait. Primary mechanism of elevated sea level: wave overtopping (red) and storm surge (yellow). The blue line indicates the trajectory of Typhoon Jebi. Locations (a–o) indicate the sequence of survey points

Fifteen locations along the coastline of the four most affected prefectures, namely, Osaka, Wakayama, Tokushima, and Hyogo (including Awaji-shima island) were surveyed (Fig. 4, Table 1). Evidence of storm surges, damage of coastal protection, and overtopping induced by high waves were observed. Figure 4 shows the field survey locations with the corresponding storm surge and wave overtopping heights. Although the total water level should have been determined by the combination of waves and storm surge, Fig. 4 distinguishes the primary mechanism for elevated sea level as being either wave overtopping or storm surge based on our onsite observations.

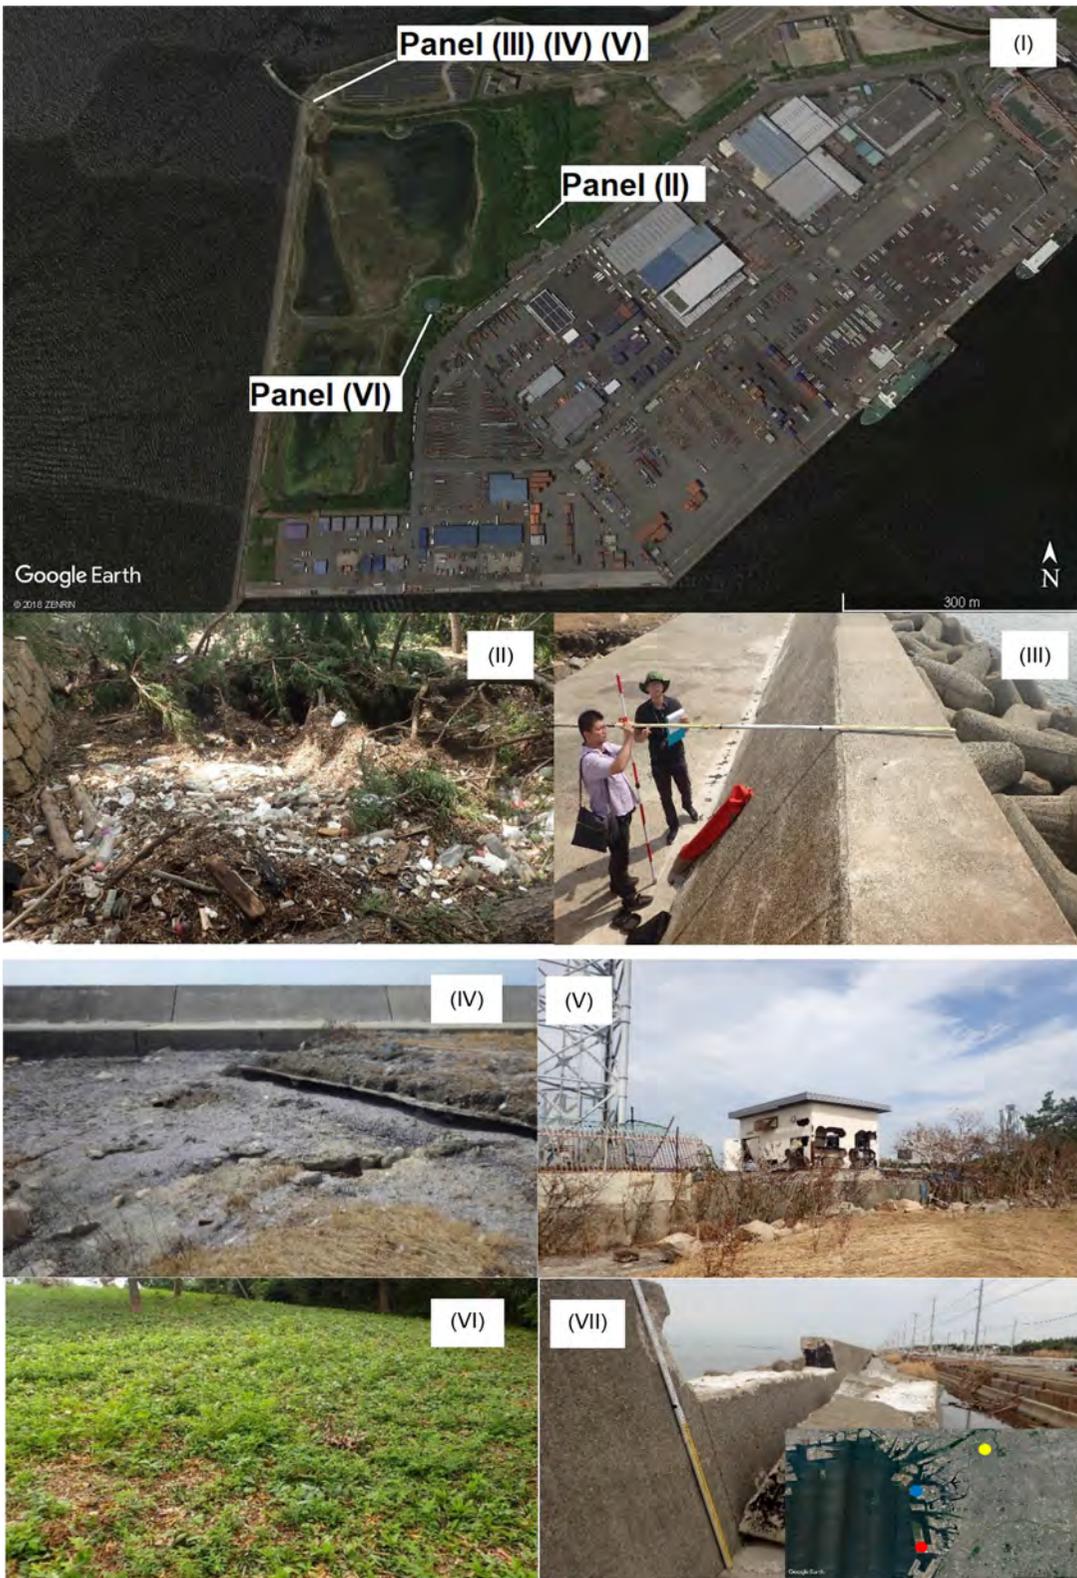
Field survey at Nanko Bird Sanctuary and Sakai [locations (a, b) in Fig. 4III]. **I** Survey locations at the sanctuary, **II** trash accumulated over the main route, **III** sea dyke, **IV** scour behind the dyke due to wave overtopping, **V** damaged building near the dyke, **VI** difference in grass color demonstrating that seawater reached a height up to the withered grass and **VII** broken parapet at Sakai City outside (red dot: Sakai, blue dot: Nanko bird filed, yellow dot: Osaka)

The Nanko Bird Sanctuary is located at the northwest corner of Sakishima artificial island in Osaka Bay and is a stopover for migrating birds on their way from the Arctic Circle to Southeast Asia to avoid winter (Fig. 5I). A broken statue surrounded by several fallen tree branches was observed at the main entrance, and many cracked big trees obstructed the main route. The soil was still wet and slippery due to the coastal flooding. Trash was gathered by the wind and floodwater (Fig. 5II). We started to investigate the site immediately behind the seashore, where a dyke with tetrapod blocks was constructed (Fig. 5III). Severe scour behind the dyke was observed (Fig. 5IV). Hence, waves should have overtopped the dyke with a height of 4.05 m relative to TP. Likewise, strong winds should have caused partial damage to the building next to the sea, evidenced by

the broken metal fence and broken windows (Fig. 5V). We measured the elevation from the sea surface to the place where a watermark evidencing the inundation height remained, as we found an obvious visible line distinguishing the inundation on a grassy hill (Fig. 5VI). We observed small white flowers on top of the hill, whereas grass had withered and disappeared (brown color ground can be seen at that place) below the line where seawater had likely reached. Given that this line was almost horizontal, seawater should have been brought by storm surge, whose height relative to TP was estimated to be approximately 3.55 m. At Sakai, the port/industrial city located at the south of Osaka, several sections of coastal dykes with a-2 m high parapet were torn apart most likely due to impressively high wave pressures (Fig. 5VII).

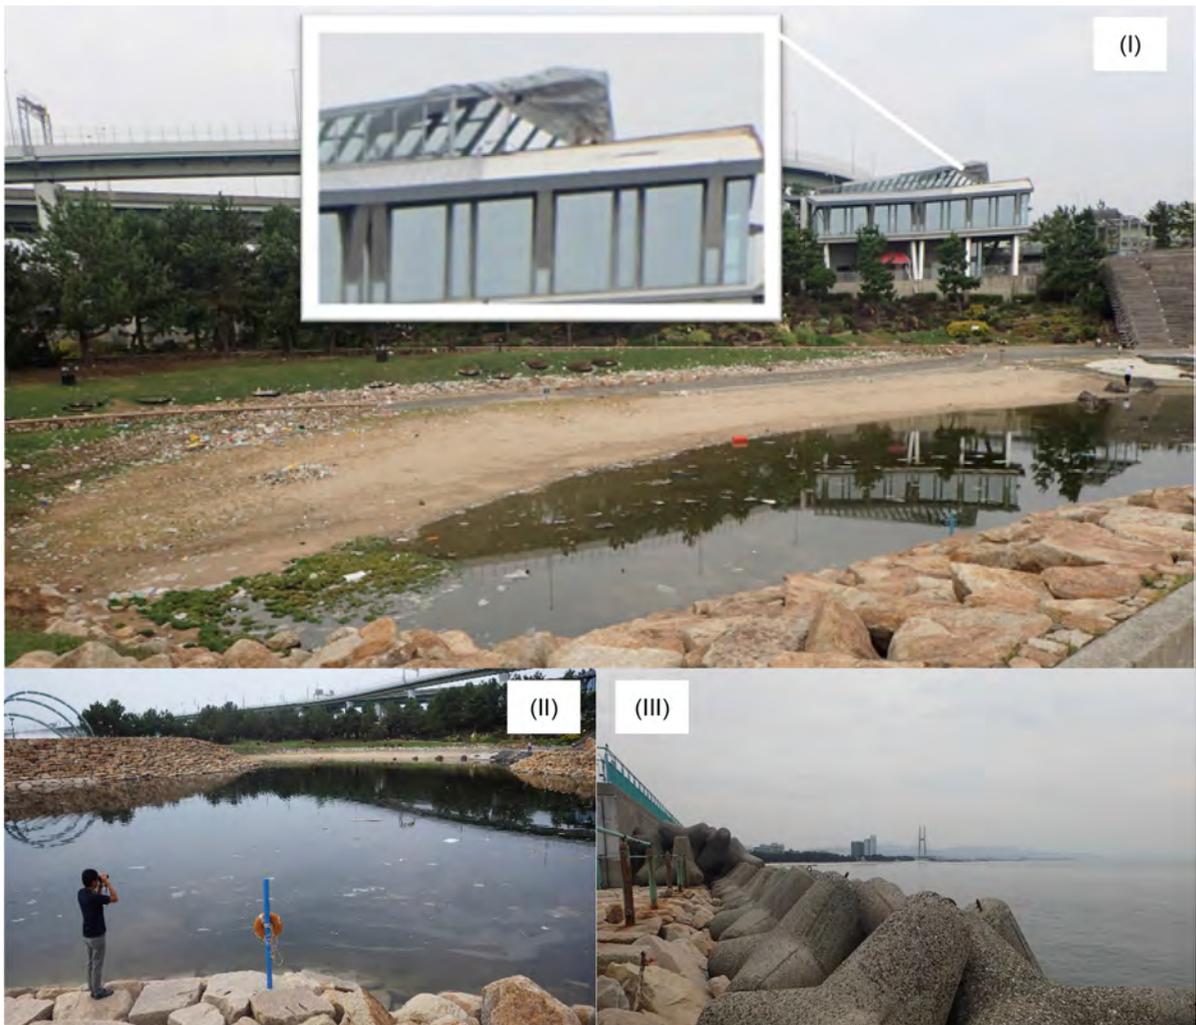
Figure 6

Field survey at Rinku Park [location (c) in Fig. 4III]. **I** Park overview two days after Typhoon Jebi impact showing trash and a damaged roof. We measured the elevation of the ground where trash remained. **II** Inner and **III** outer protection layers of the park

We conducted a survey at the Rinku Park located on the opposite side of Kansai International Airport (Fig. 6). The Rinku Park attracts tourists who arrive from the airport and local people by its greenery, seaside seeing spots, and long walking trails. However, Typhoon Jebi severely damaged the park, and the access for visitors was suspended. When we visited the park 2 days after Jebi, several fallen tree branches remained on the ground near the entrance. Trash was scattered everywhere, though no visible damage to the park infrastructure was observed, except for a roof damage caused by strong winds (the roof cover panels were blown away) (Fig. 6I). No residences are located around the park area. The inundation height was evidenced by the remaining trash on the artificial beach of the park. We measured the elevation from the sea level at the time of our survey to the highest line of visible trash (Fig. 6II),

estimating an inundation height of 5.47 m relative to TP. The park was well protected from the sea by a two-layer infrastructure comprising an outer thick tetrapod layer and an inner large stone barrier. Both layers did not suffer any considerable damage showing that the wave force was not significantly strong, and only wave overtopping caused inundation (Fig. 6II, III). The elevation of the stone dyke is about 1.8 m above the mean sea level.

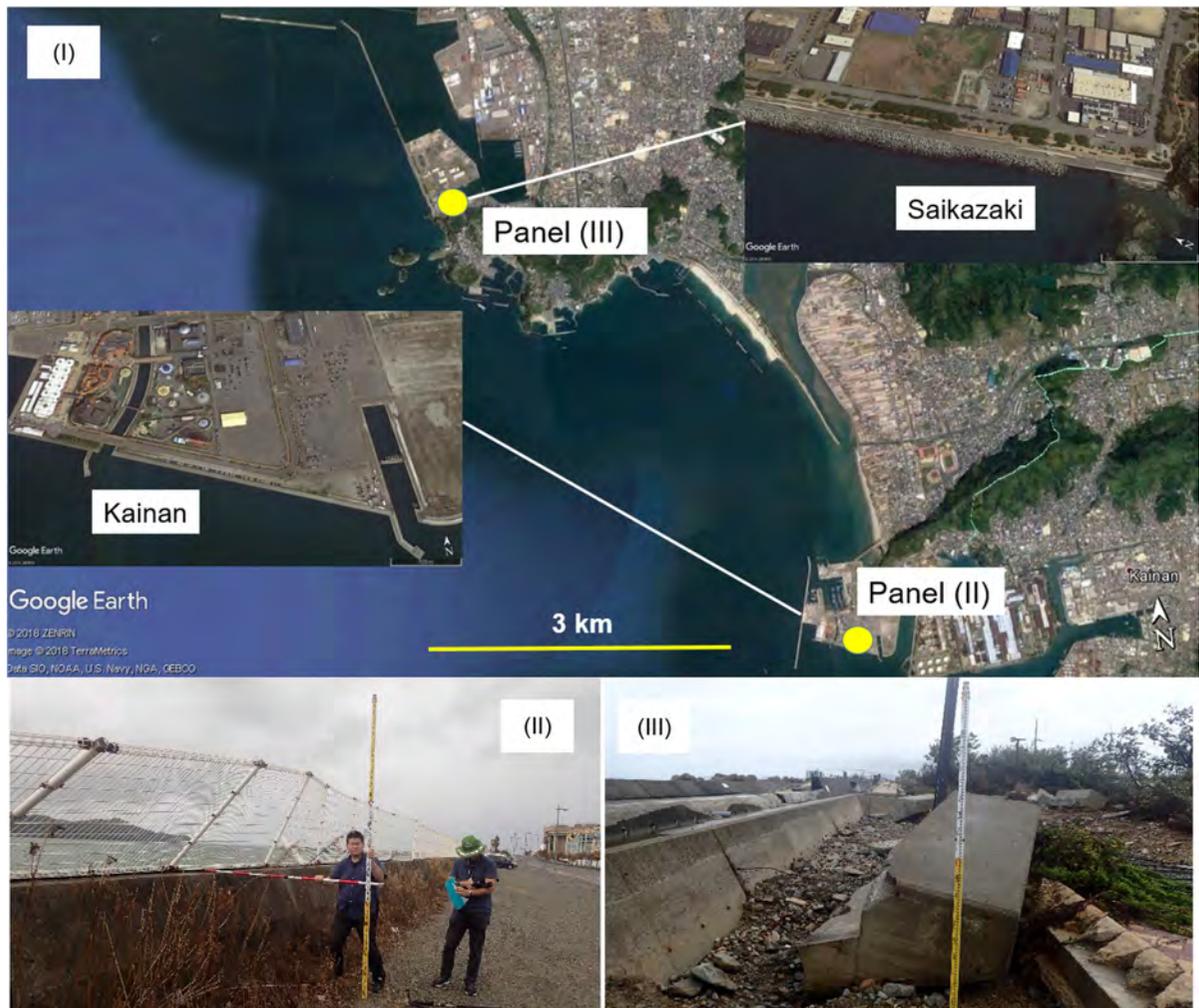
Figure 7

Field survey at Wakayama [locations (d, e) in Fig. 4IV]. **I** Localization of Kainan and Saikazaki, **II** coastal fence smashed by high waves at Kainan, **III** broken parapet by overtopping waves at Saikazaki

Kainan and Saikazaki are located at the northwest coast of the Wakayama Prefecture (Fig. 7I). We found no clear evidence of extensive inundation induced by storm surges in the typhoon aftermath. However, damage caused by wave overtopping were observed at many locations. At Kainan, we visited an entertainment park (Wakayama Marina City), and all

the buildings looked robust against strong winds and exhibited no visible damage. However, we found evidence of wave overtopping in a coastal fence of 1.2 m high, which was smashed by high waves. The waves reached at least 2.7 m above the sea level (Fig. 7II). By using the GPS receivers, we measured elevations relative to TP of 4.14 and 6.03 m at Kainan and Saikazaki, respectively.

One of the coastal protection structures in Saikazaki seemed to be sufficiently strong against waves, but this area has two dyke layers, each with approximately 2-m parapets and armoring brocks supporting the first dyke. However, the parapet of the second dyke was smashed by overtopping waves, causing a deep hole due to scouring (Fig. 7III). The damage at this place was much severer than that at Kainan, suggesting that even neighboring coasts may have experienced different levels of wave impact by multiple factors such as the presence of offshore

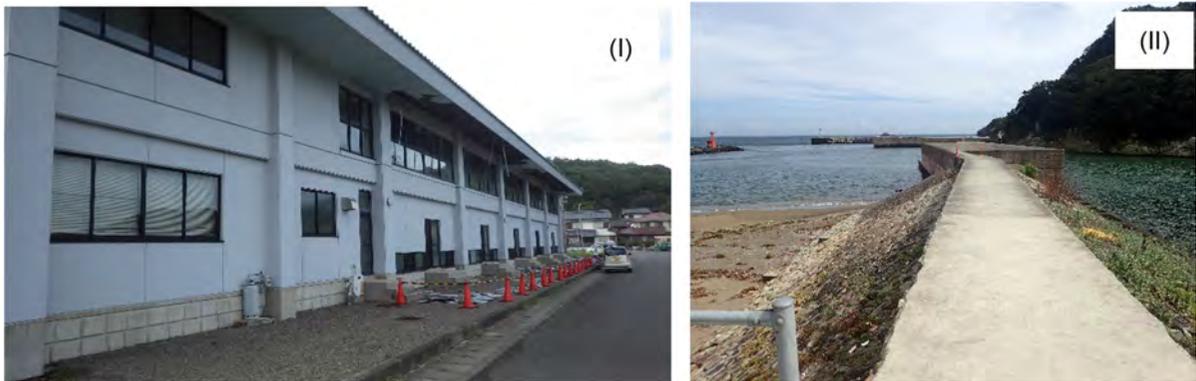
Figure 8

Field survey at Tokushima [locations (f, g) in Fig. 4IV]. **I** Damaged roof in a village from Anan, **II** high sea dyke at Minami Awa

We visited a coastal village of Anan City, Tokushima (Fig. 8). This place is naturally protected by several islands. Although roofs and windows of a public sports hall were broken by strong winds (Fig. 8I), no serious damage was caused by coastal floods. A resident witnessed a quickly raising water level

during Typhoon Jebi. Although the waves did not exceed the dike, seawater intruded through a sewage pipe and partially flooded her house. A beach in Minami Awa Town located at the Southeast coast of Shikoku island has a sea dyke at approximately 4.7 m high from the ground, which effectively protected the village against high waves during Typhoon Jebi. According to another resident, high waves ran up and left many driftwoods on the sandy beach, but there was no considerable damage (Fig. 8II). Our measurements revealed that waves carried woods at least 5.1 m higher than TP.

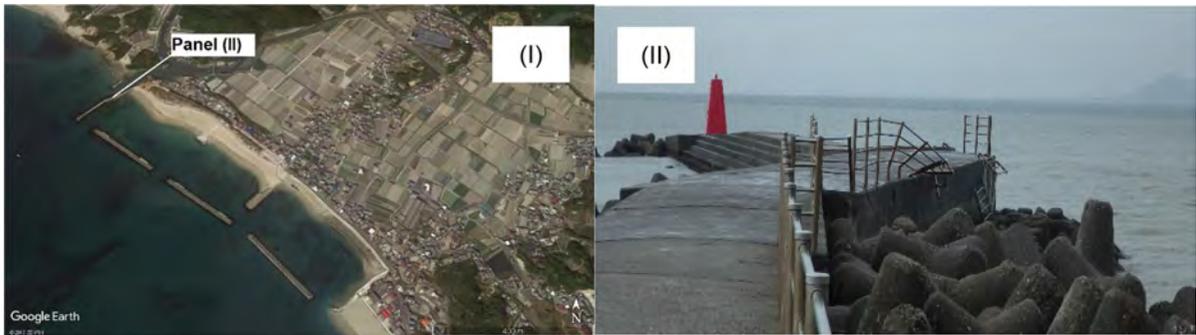
Figure 9

Field survey at Honjo river mouth [location (h) in Fig. 4IV]. **I** Location of training wall and **II** smashed handrail of the training wall

The Awaji-shima island is a remote island located next to Osaka Bay. We began the field survey at the Honjo river mouth located at the southern part of the island. There is a sandy beach separated from the Honjo river by a training wall (Fig. 9I). Several breakwaters parallel to the beach protect the coast. Trash, sand, and broken tree branches were on the beach, and the handrail of the training

wall had been apparently smashed by high waves and fell to the river (Fig. 9II). The direction of the fallen handrail suggests the primary direction of high waves, and the height from the local sea level to the top of the training wall was 3.77 m relative to TP, but we found no clear evidence of coastal inundation here.

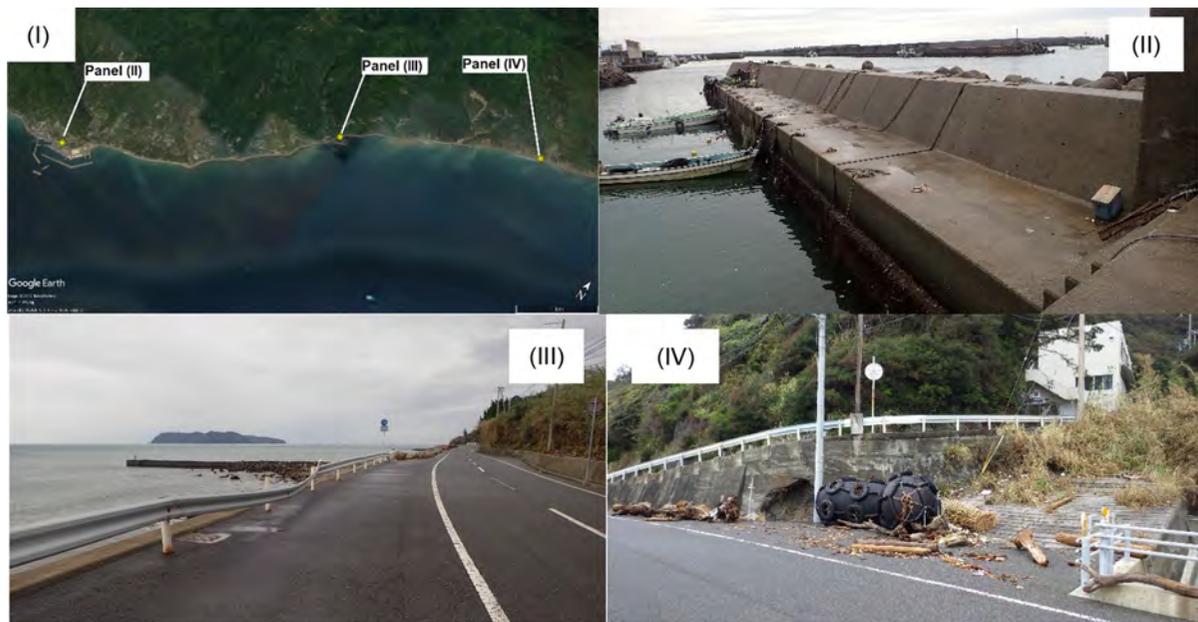
Figure 10

Field survey at eastern coast of Awaji-shima island [locations (i–k) in Fig. 4IV]. **I** Location of surveyed places, **II** armored breakwater at Minami Awa Fishing Port, **III** smashed guardrail at Awa Nadakuroiwa, **IV** rubber fenders found at Awa Nadashirosaki caused a large punching hole on a wall

The authors focused on the eastern coast of the island and carried out the field survey at several locations (Fig. 10I). The Minami Awa Fishing Port was protected by breakwaters with armor brocks on the sea side (Fig. 10II). Scattered fishing tools

indicated that the internal breakwater was overtopped. However, no considerable damage was observed at the port. Close to the fishing port, we found a road guardrail (reaching 6.37 m relative to TP) that was bent towards the land (Fig. 10III). Two large rubber fenders ($3 \text{ m} \times 1.3 \text{ m} \times 1.7 \text{ m}$) were washed away along with driftwoods by high waves and found on the coastal road at 5.77 m relative to TP. The wave force was strong enough to create a hole of $3.7 \text{ m} \times 2 \text{ m}$ on the wall behind the road (Fig. 10IV).

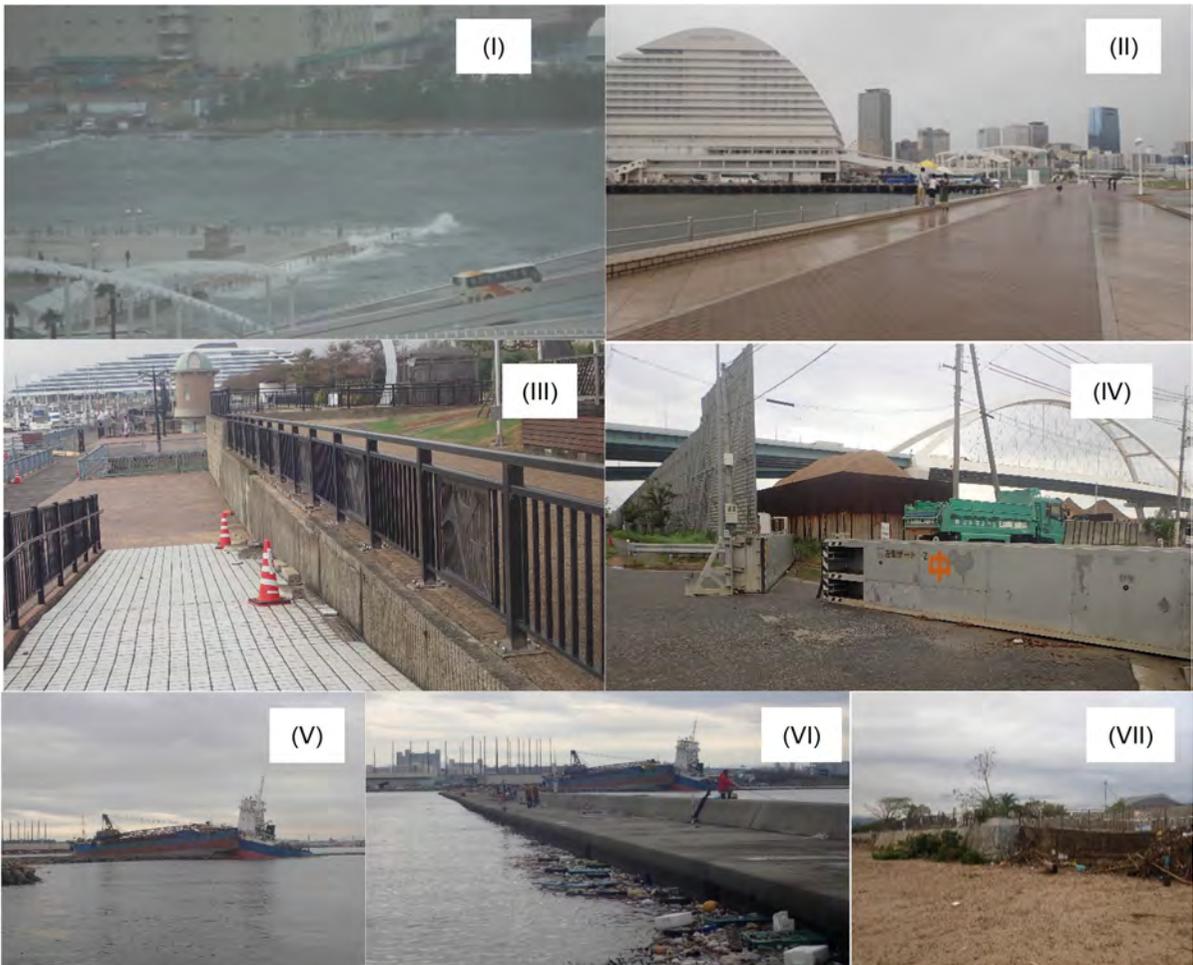
Figure 11

Field survey at Kobe city [locations (I–o) in Fig. 4III]. **I** Kobe Meriken Park storm surge and high waves during Typhoon Jebi (rough sea screenshot from online live camera at 14:17, September 4, 2018, Japan Standard Time) (<https://www.youtube.com/watch?v=lCupBcgCuO8>), **II** situation after 4 days of the typhoon at Kobe Meriken Park, **III** fallen bricks at Nishinomiya Yacht Harbor, **IV** destroyed inland floodgate at Amagasaki Port, **V** stranded large vessel at Amagasaki Port, **VI** trash gathered behind breakwater, **VII** Koshienhama Artificial Beach, where wave overtopping was confirmed

The Meriken Park in Kobe City was flooded due to high waves and storm surge, which overtopped the terrace of the park with elevation of 2.72 m relative to TP (Fig. 11I). Typhoon Jebi with strong winds of around 34.6 m/s (at Kobe airport) coincided with the flood tide period. Trash and debris had been already cleared when we visited the park 4 days after the typhoon (Fig. 11II). The building around the Meriken Park did not suffer considerable damage. We also investigated the Yacht Harbor in Nishinomiya, Hyogo Prefecture. The breakwater protected the harbor, preventing consequences from waves. However, there was a small damage on the wall at

approximately 3.34 m above the sea level (TP), as confirmed by fallen bricks (Fig. 11III). We observed the inland floodgate destroyed (Fig. 11IV) and a stranded large vessel on the top of the breakwater inside the Amagasaki Port, which is located next to the harbor (Fig. 11V). As this location belongs to the innermost part of the Osaka Bay, waves appear to be small under normal weather conditions. Therefore, the breakwater was constructed relatively low in height at only 2.04 m relative to TP. A high amount of trash was also accumulated on top of the breakwater, demonstrating wave overtopping (Fig. 11VI). An artificial beach in front of the residential area, named Koshienhama, was also damaged by high waves (Fig. 11VII). Based on the observed trash and driftwood left on top of the dyke, we confirmed that waves reached at least 4.91 m relative to TP, just

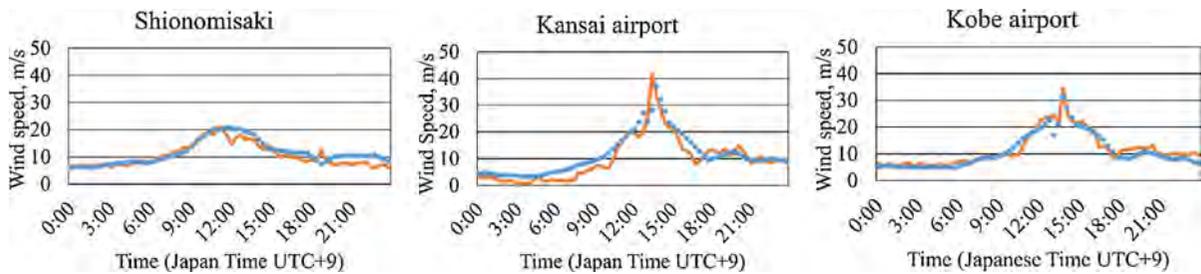
Comparison between wind speed obtained from the JMA mesoscale spectral model (blue dotted line) and observed data (orange solid line) on 4 September 2018 (time in Japan Standard Time, UTC + 9)

Before importing the wind speeds derived from the JMA GPVs as input to the hydrodynamic and wave model, we verified them with observed data from the stations. The observed data were measured at the relevant weather observation stations operated by the JMA (see Fig. 2). Figure 12 compares the observed and calculated wind speed at three stations, namely, Shionomisaki, Kansai airport, and Kobe airport. Despite the discrepancies between the measurements and estimations, the data from the GPVs show good agreement with the observed data at the peak time, with a slight underestimation (3–5 m/s). Air pressure measurements were taken from Shionomisaki, Tokushima, and Kobe stations due to the missing functions at some stations. The GPV air pressure data (988 hPa) at Shionomisaki retrieved a slight

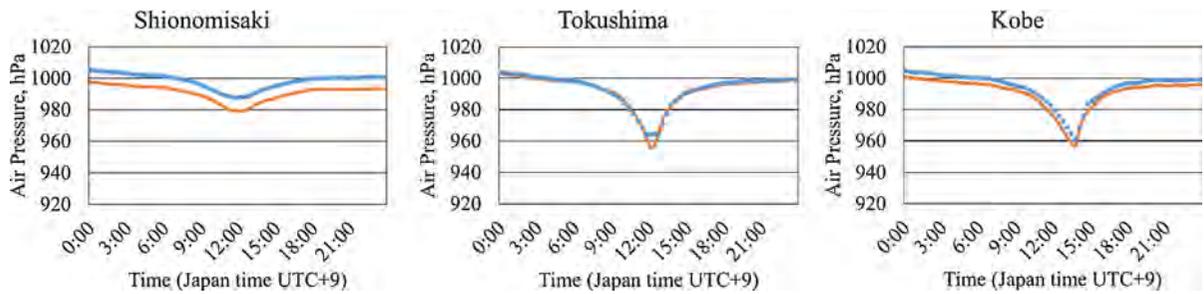
Figure 13

Comparison between air pressure obtained from the JMA mesoscale spectral model (blue dotted line) and observed data (orange solid line) on 4 September 2018 (time in Japan Standard Time, UTC + 9)

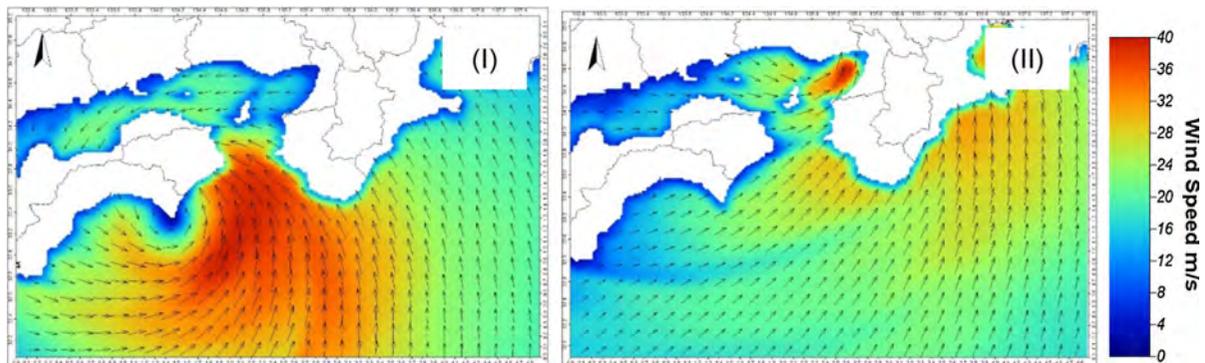
Figure 14

Wind field distribution during Typhoon Jebi passage **I** over Kii Strait on September 4, 2018 at 11:00 and **II** inside Osaka Bay at 14:00 (Japan Standard Time, UTC + 9)

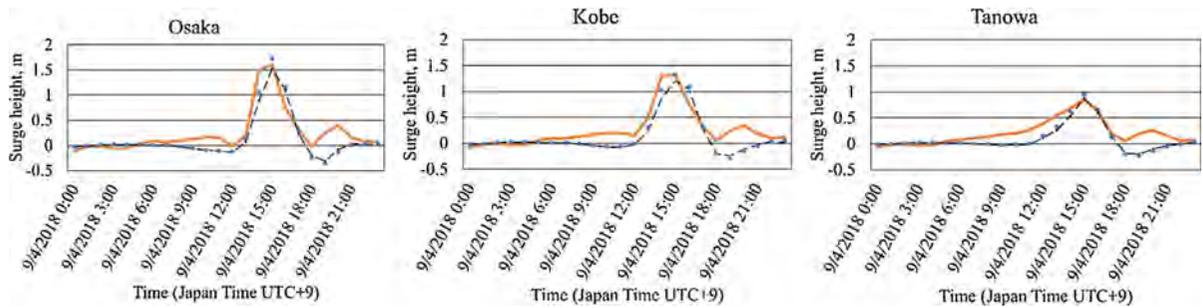
Comparison of calculated surge level with flow–wave interaction (blue dotted line), no interaction with wave (black dash line), and observed values (orange solid line) during Jebi passage

the water level in Osaka Bay by approximately 10%. Results from numerical simulations of the surge component caused by Jebi and using the coupled model are compared with real data at Tanowa, Kobe, and Osaka respectively in Fig. 15. The increasing water level during the passage of Jebi is suitably reflected by Delft3D-FLOW model (maximum difference was about 10% at Tanowa, RMS values of 0.23, 0.21, and 0.18 at Osaka, Kobe, and Tanowa, respectively). Figure 15 shows that the simulated surge height reached up to 1.75 m in Osaka, while the observed data was 1.61 m from the tidal gauge. This small overestimation can be partially attributed to the land-boundary condition in the model, which does not consider overflow, whereas coastal floods took place in some port areas (Takabatake et al. 2018). The water surface elevation at Osaka started increasing at 13:00 and reached its peak at 15:00, while 47.4 m/s of maximum wind speed was recorded in

Osaka at 14:10. Thus, there is about a 1-h lag between the growth of wind speed and water level. Similar lag times were observed at Tanowa and Kobe. The spatial distribution of the maximum surge level when Jebi crossed the Kii strait and hit land at Osaka are shown in Fig. 16.

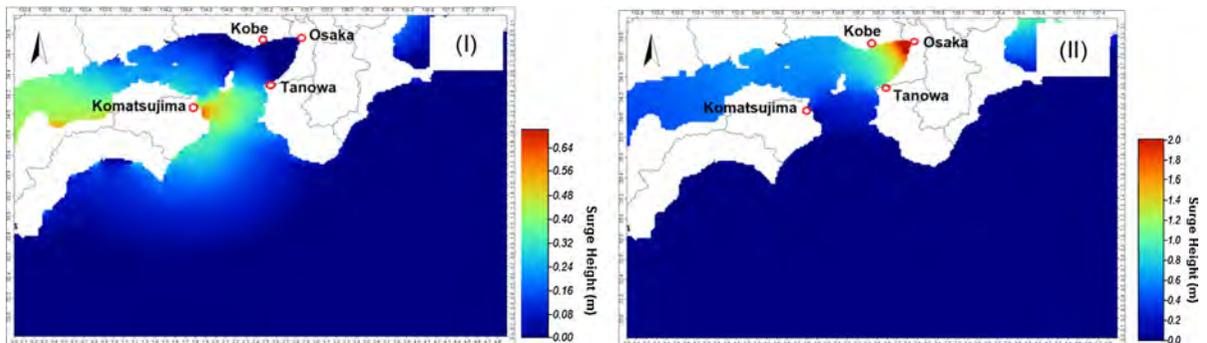
Figure 16

Storm surge distribution during Typhoon Jebi passage **I** over Kii Strait on September 4, 2018 at 12:00 and **II** inside Osaka Bay at 15:00 (Japan Standard Time, UTC + 9)

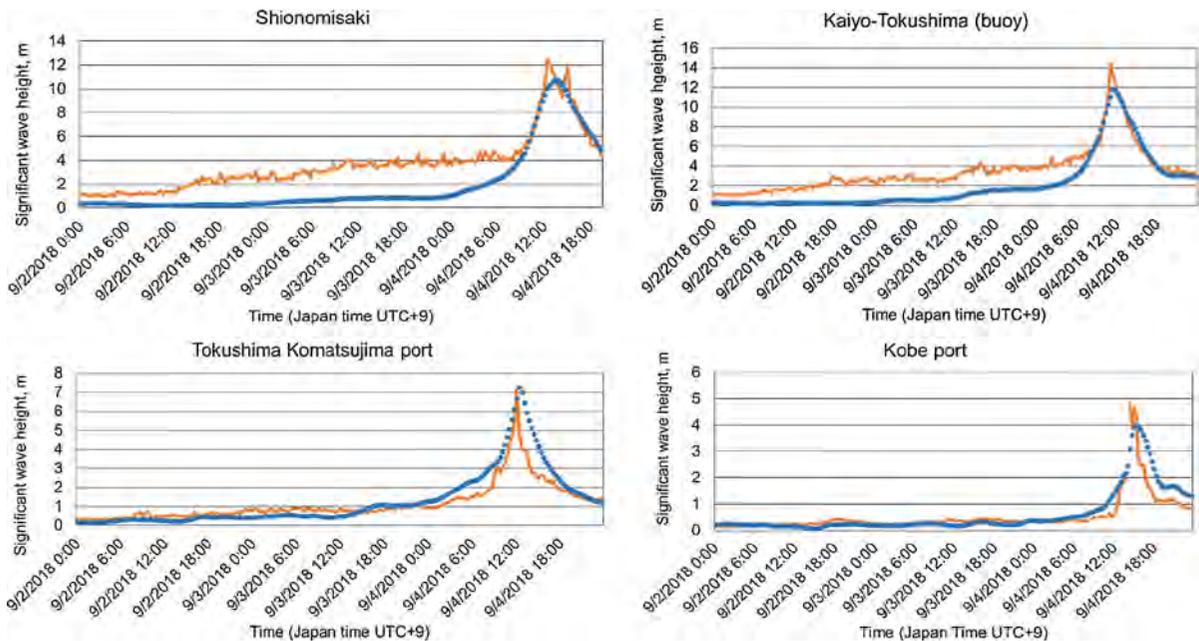
Significant wave height obtained from our surge-wave model (blue dotted line) and observed data (orange solid line). Time is expressed in Japan Standard Time, UTC + 9

depth-limited condition is relaxed due to the increased water depth. Hereafter, the wave simulation coupled with the flow simulation is considered to account for the influence of the wave–flow interaction. Figure 17 shows the simulation accuracy by comparing the estimated significant wave height with data measured from NOWPHAS, showing a reasonable agreement especially at the peak values at all stations. The model underestimates the significant wave height by up to 2.7 m at the Kaiyo Tokushima buoy likely by the difference in wind speed. The measured wind speed at Murotomisaki station (Fig. 2) near Kaiyo Tokushima was 47.7 m/s, which was much higher than the 30.3 m/s obtained from the GPV model. The simulation results also underestimated the real data at Shionomisaki and Kobe, while a slight overestimation (0.1 m) was found at Komatsujima. The mesoscale model has a limitation to

estimate the wind field, particularly near the center of typhoons (Tanemoto and Ishihara 2013, 2015). As the Murotomisaki station and Kaiyo Tokushima buoy were closer to the Jebi track than other stations, the wave height tends to be underestimated. Simulation waves at Tokushima-Komatsujima and Kobe port show better RMS values (0.62 m and 0.37 m, respectively) than the other two offshore stations, Kaiyo-Tokushima and Shionomisaki (2.98 and 2.04, respectively).

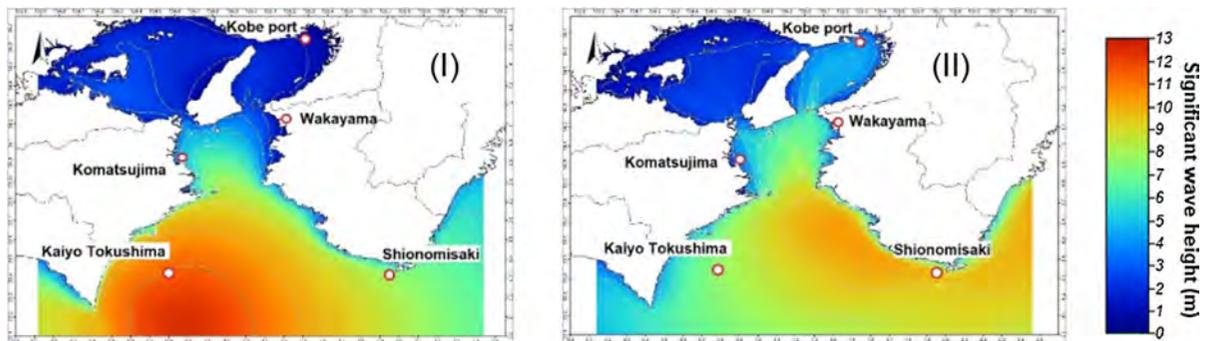
Figure 18

Significant wave height distribution during Typhoon Jebi passage **I** over Kii Strait on September 4, 2018 at 11:00 and **II** inside Osaka Bay at 14:00 (Japan Standard Time, UTC + 9)

Figure 18I shows that the maximum significant wave height was nearly 13 m in the strait between Shikoku and Honshu island when the typhoon made landfall at the coast of the Tokushima Prefecture. The east coast of Shikoku island suffered the highest wave about 2 h before the west coast of Wakayama Prefecture was affected. The simulation also shows

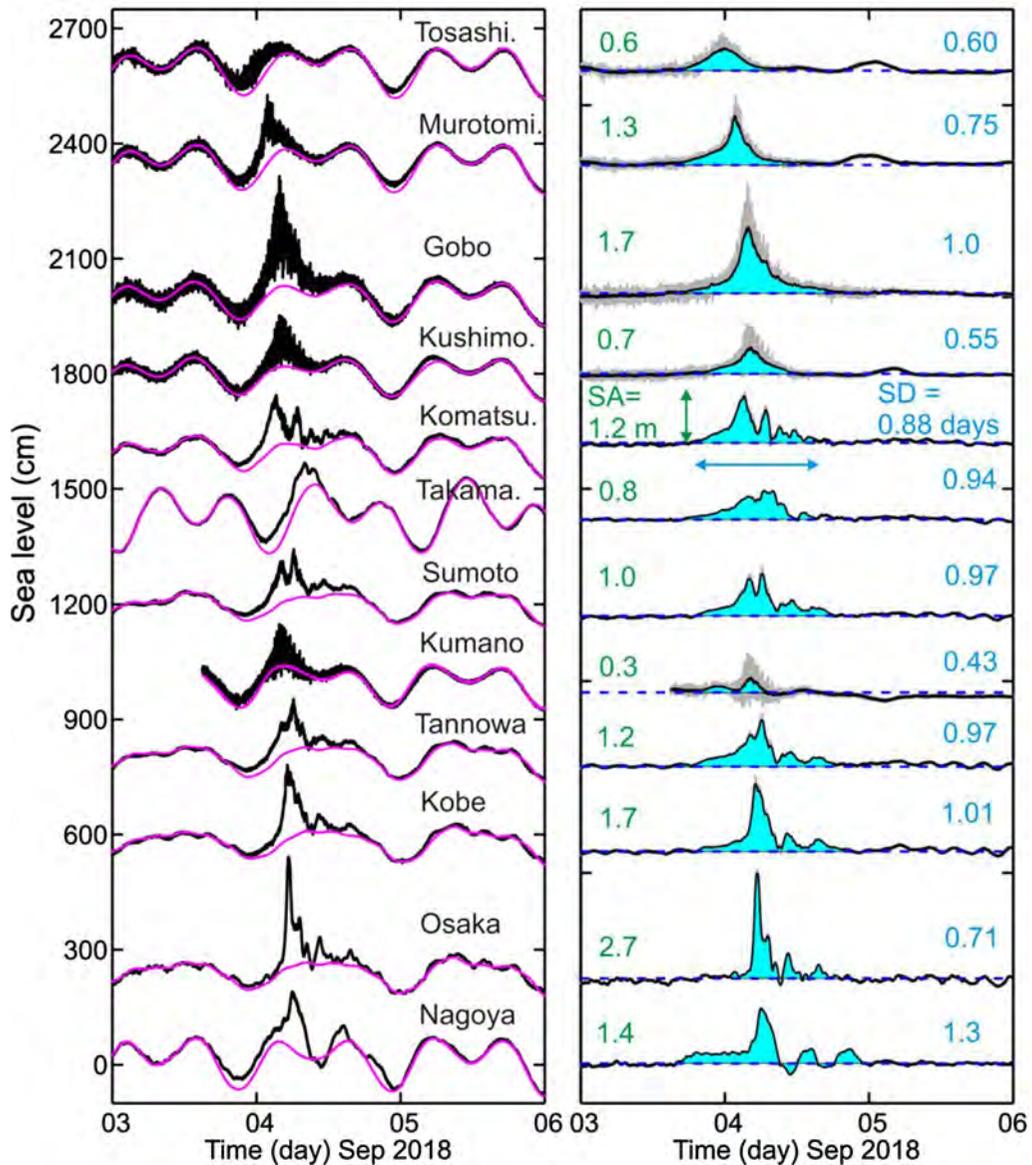
Figure 19

Sea level in September 2018 affected by Typhoon Jebi based on analyses of tide gauge data. **a** Original tide gauge records (black) and tide prediction (pink). **b** SA and SD at different tide gauge stations (black solid lines, 15-min average waveforms to remove wave effects)

in this study, the SA and SD were in the ranges of 0.3–2.7 m and 0.43–1.3 days, respectively. The highest SA and SD were observed in Osaka (2.7 m) and Kobe (1.3 days), respectively. The two locations experiencing the highest SA were Kobe and Osaka, located at the end of Osaka Bay. This can be likely due to the funneling of the storm surge at the end of the bay. Stations located very close (< 50 km) to the typhoon trajectory (e.g., Murotomisaki, Komatsujima, Sumoto, and Tannowa) recorded SAs above 1 m, whereas farther locations (e.g., Kushimoto, Kumano, Tosashimizu, and Takamatsu) experienced SAs below 1 m (Fig. 3). The only exception is Nagoya, which registered a SA of 1.4 m despite of being located at approximately 80 km from the typhoon trajectory.

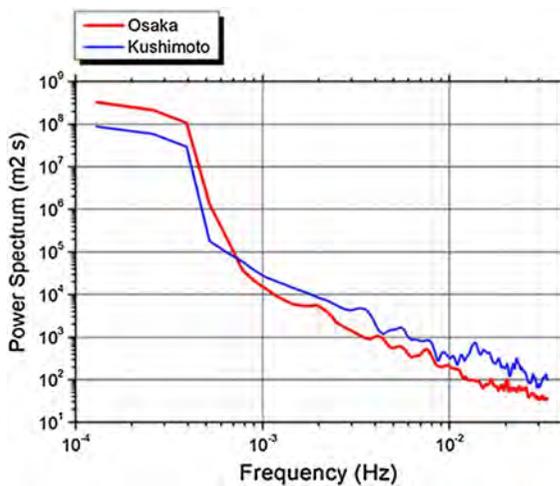
Figure 20

Power spectrum of component waves during 12 h including the arrival time of Typhoon Jebi

typhoon that propagates over the open ocean may also amplify water levels near the coast through specific resonance mechanisms (i.e., Proudman, Greenspan, or shelf resonance) (Monserrat et al. 2006). For example, a very strong seiche-type oscillation, locally known as *abiki*, was observed in Nagasaki Bay, Japan, during the event of 31 March 1979, causing an abnormal tidal fluctuation of 2.78 m excited by a moving low-pressure system (Hibiya and Kajiura 1982). Although we did not investigate this phenomenon, it is possible that the present coastal flood might have been partially exacerbated by this kind of resonance mechanisms in Osaka Bay.
